# **SOUTH HARRISBURG SINKHOLE EVALUATION WORK ORDER # 2**

## **HARRISBURG, PA**

**November 2014**

**Project Number: 59166**

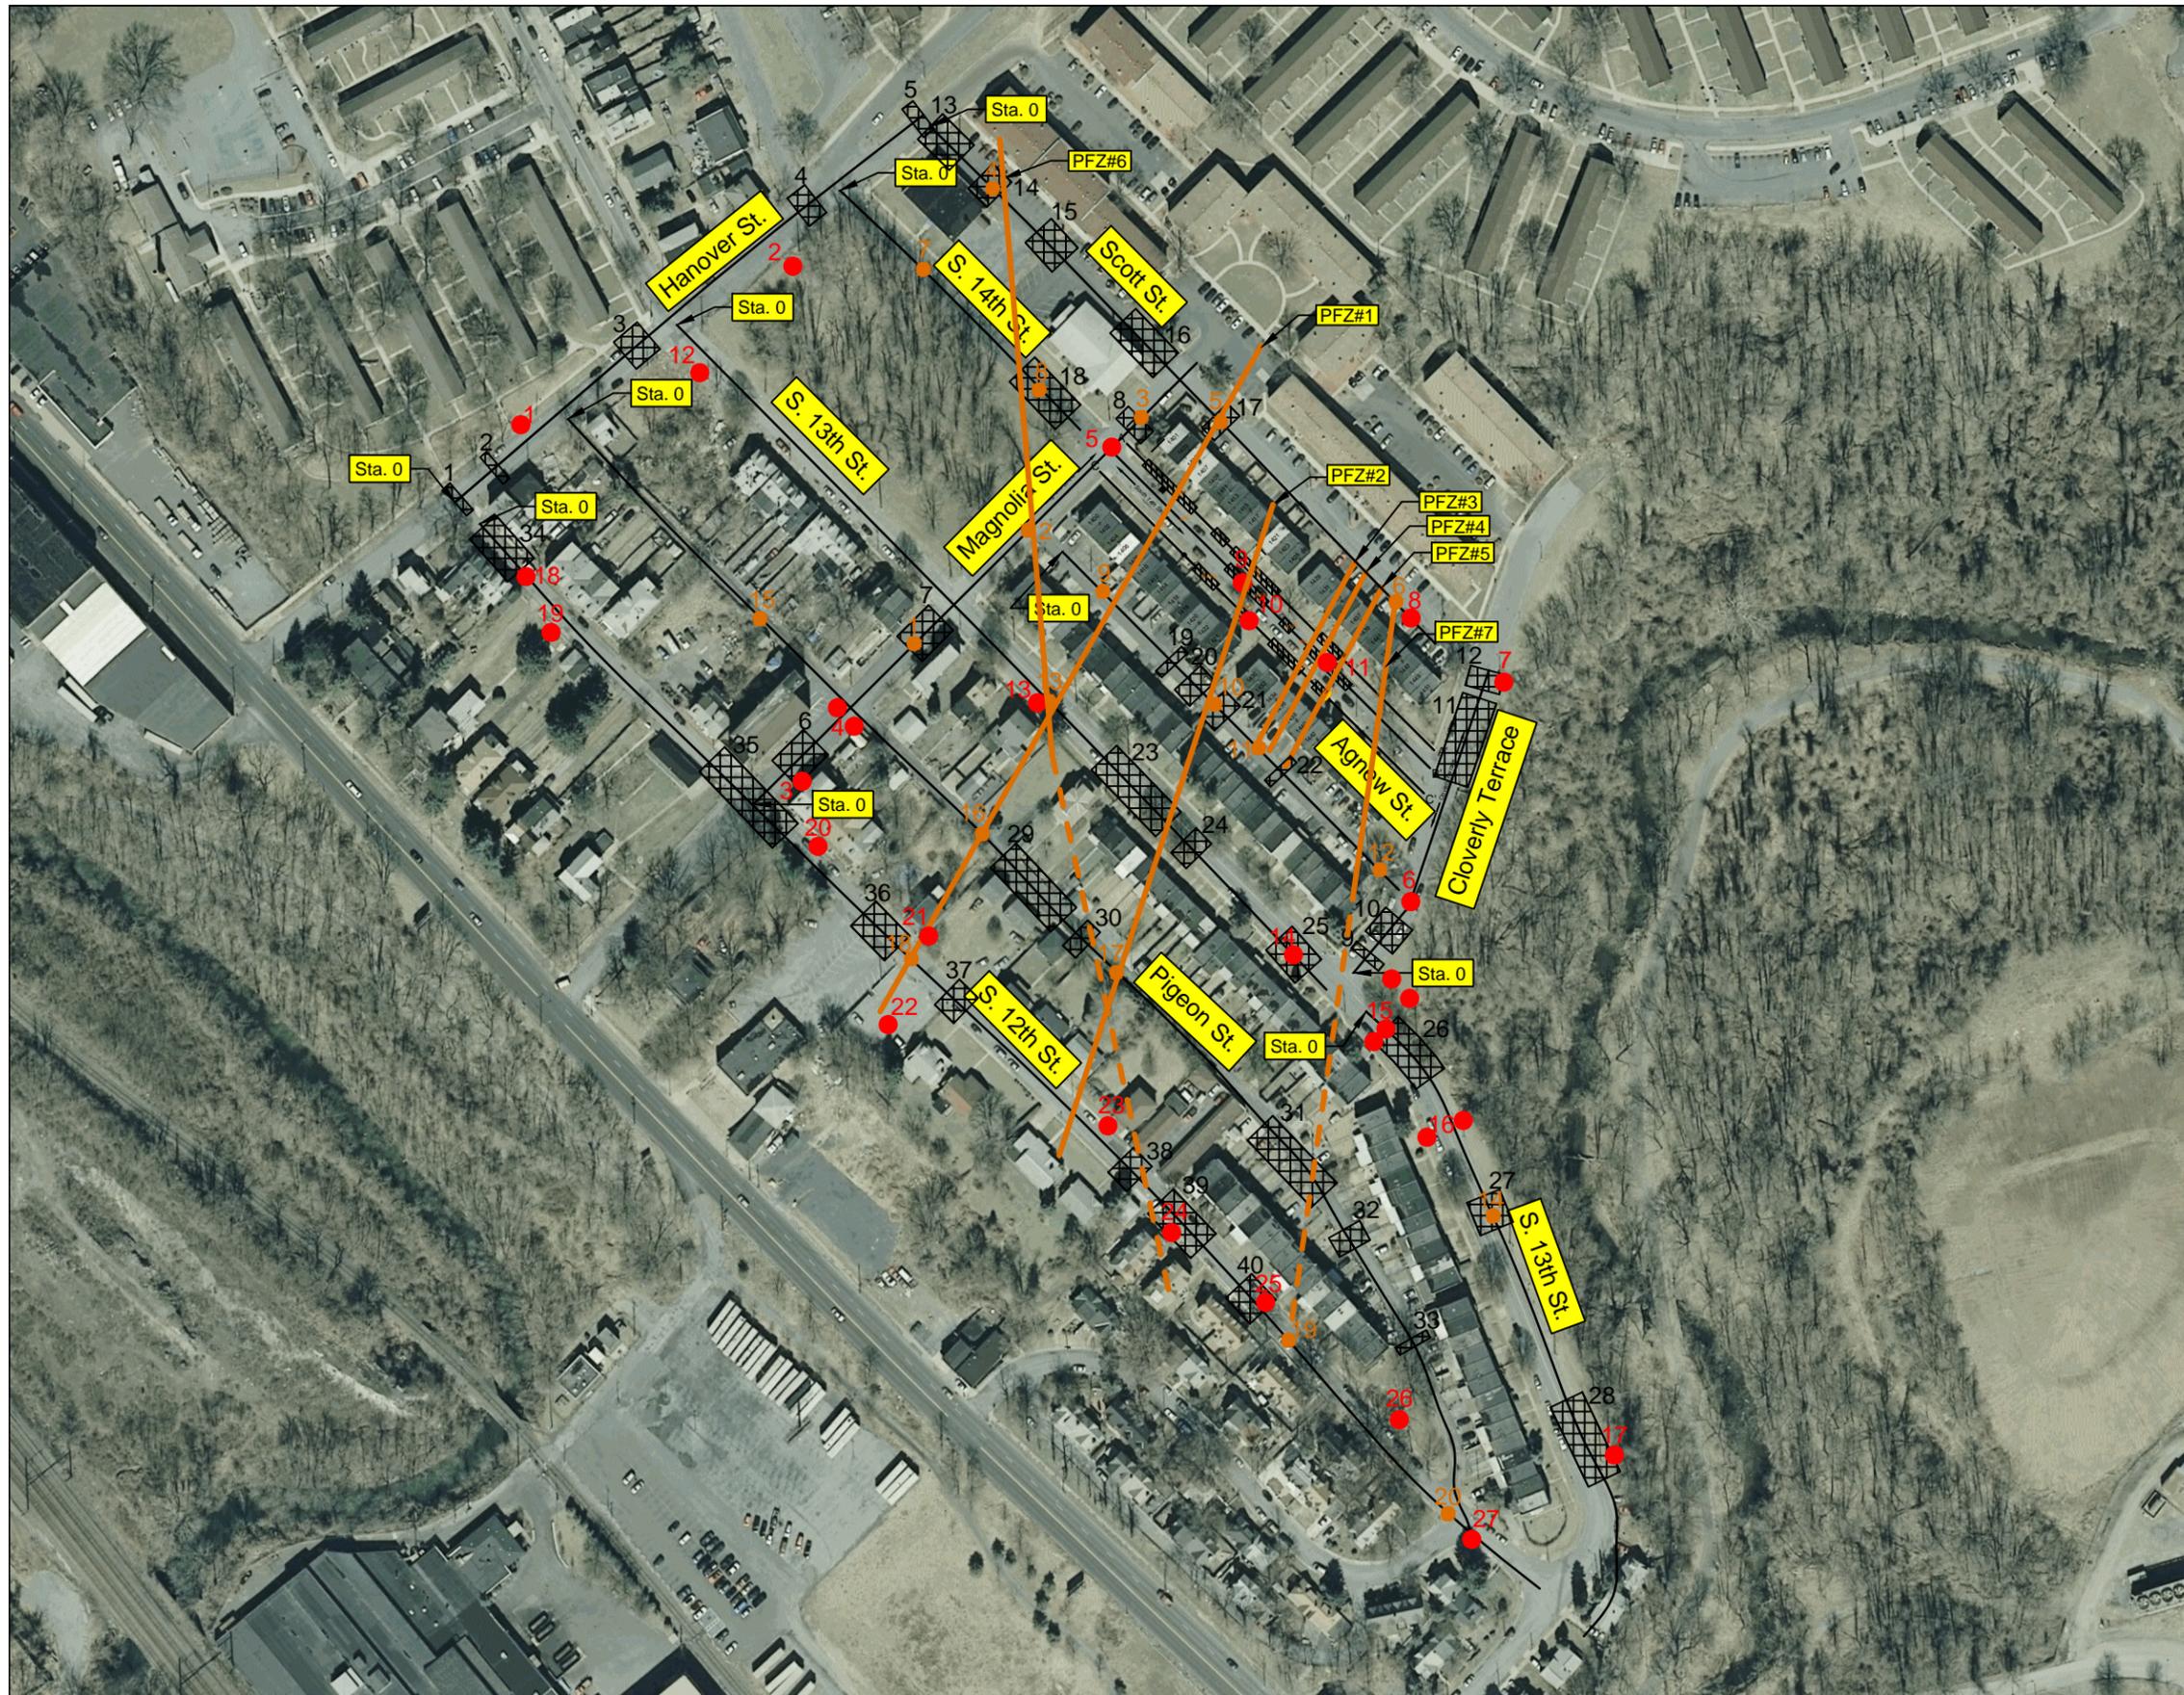
**Map of Geophysical Findings  
South Harrisburg Sinkhole Evaluation W.O.#2  
Harrisburg, Pennsylvania**

Twenty (20) fracture-like anomalies were observed. They are designated #1 through #20 in the profiles and are plotted in Figure 13. Some fracture-like anomalies such as #1 in Figure 4 and #10 in Figure 8 appear to extend to the top of the rock surface and are associated with a localized depression in the TOR. Soil piping (raveling) can be expected where fractures extend to the rock surface because fractures are planes of weakness that can allow soils to migrate into openings (voids) at depth.

Based on the judgement of the geophysist, some of the fracture-like anomalies, in collaboration with those identified in Work Order #1, “line-up” to form seven potential fractures. They are shown in Figure 13 as PFZ#1 through PFZ#7. PFZ#1 through PFZ#5 trend approximately northeast-southwest; PFZ#6 and PFZ#7 trend close to north-south. PFZ#1 through PFZ#5 were identified in Work Order #1; PFZ#1 and PFZ#2 have been extended further to the south based upon the results of Work Order #2. PFZ#6 is based on Work Order #2 findings. PFZ#7 is based on both Work Order #1 and Work Order #2 findings.

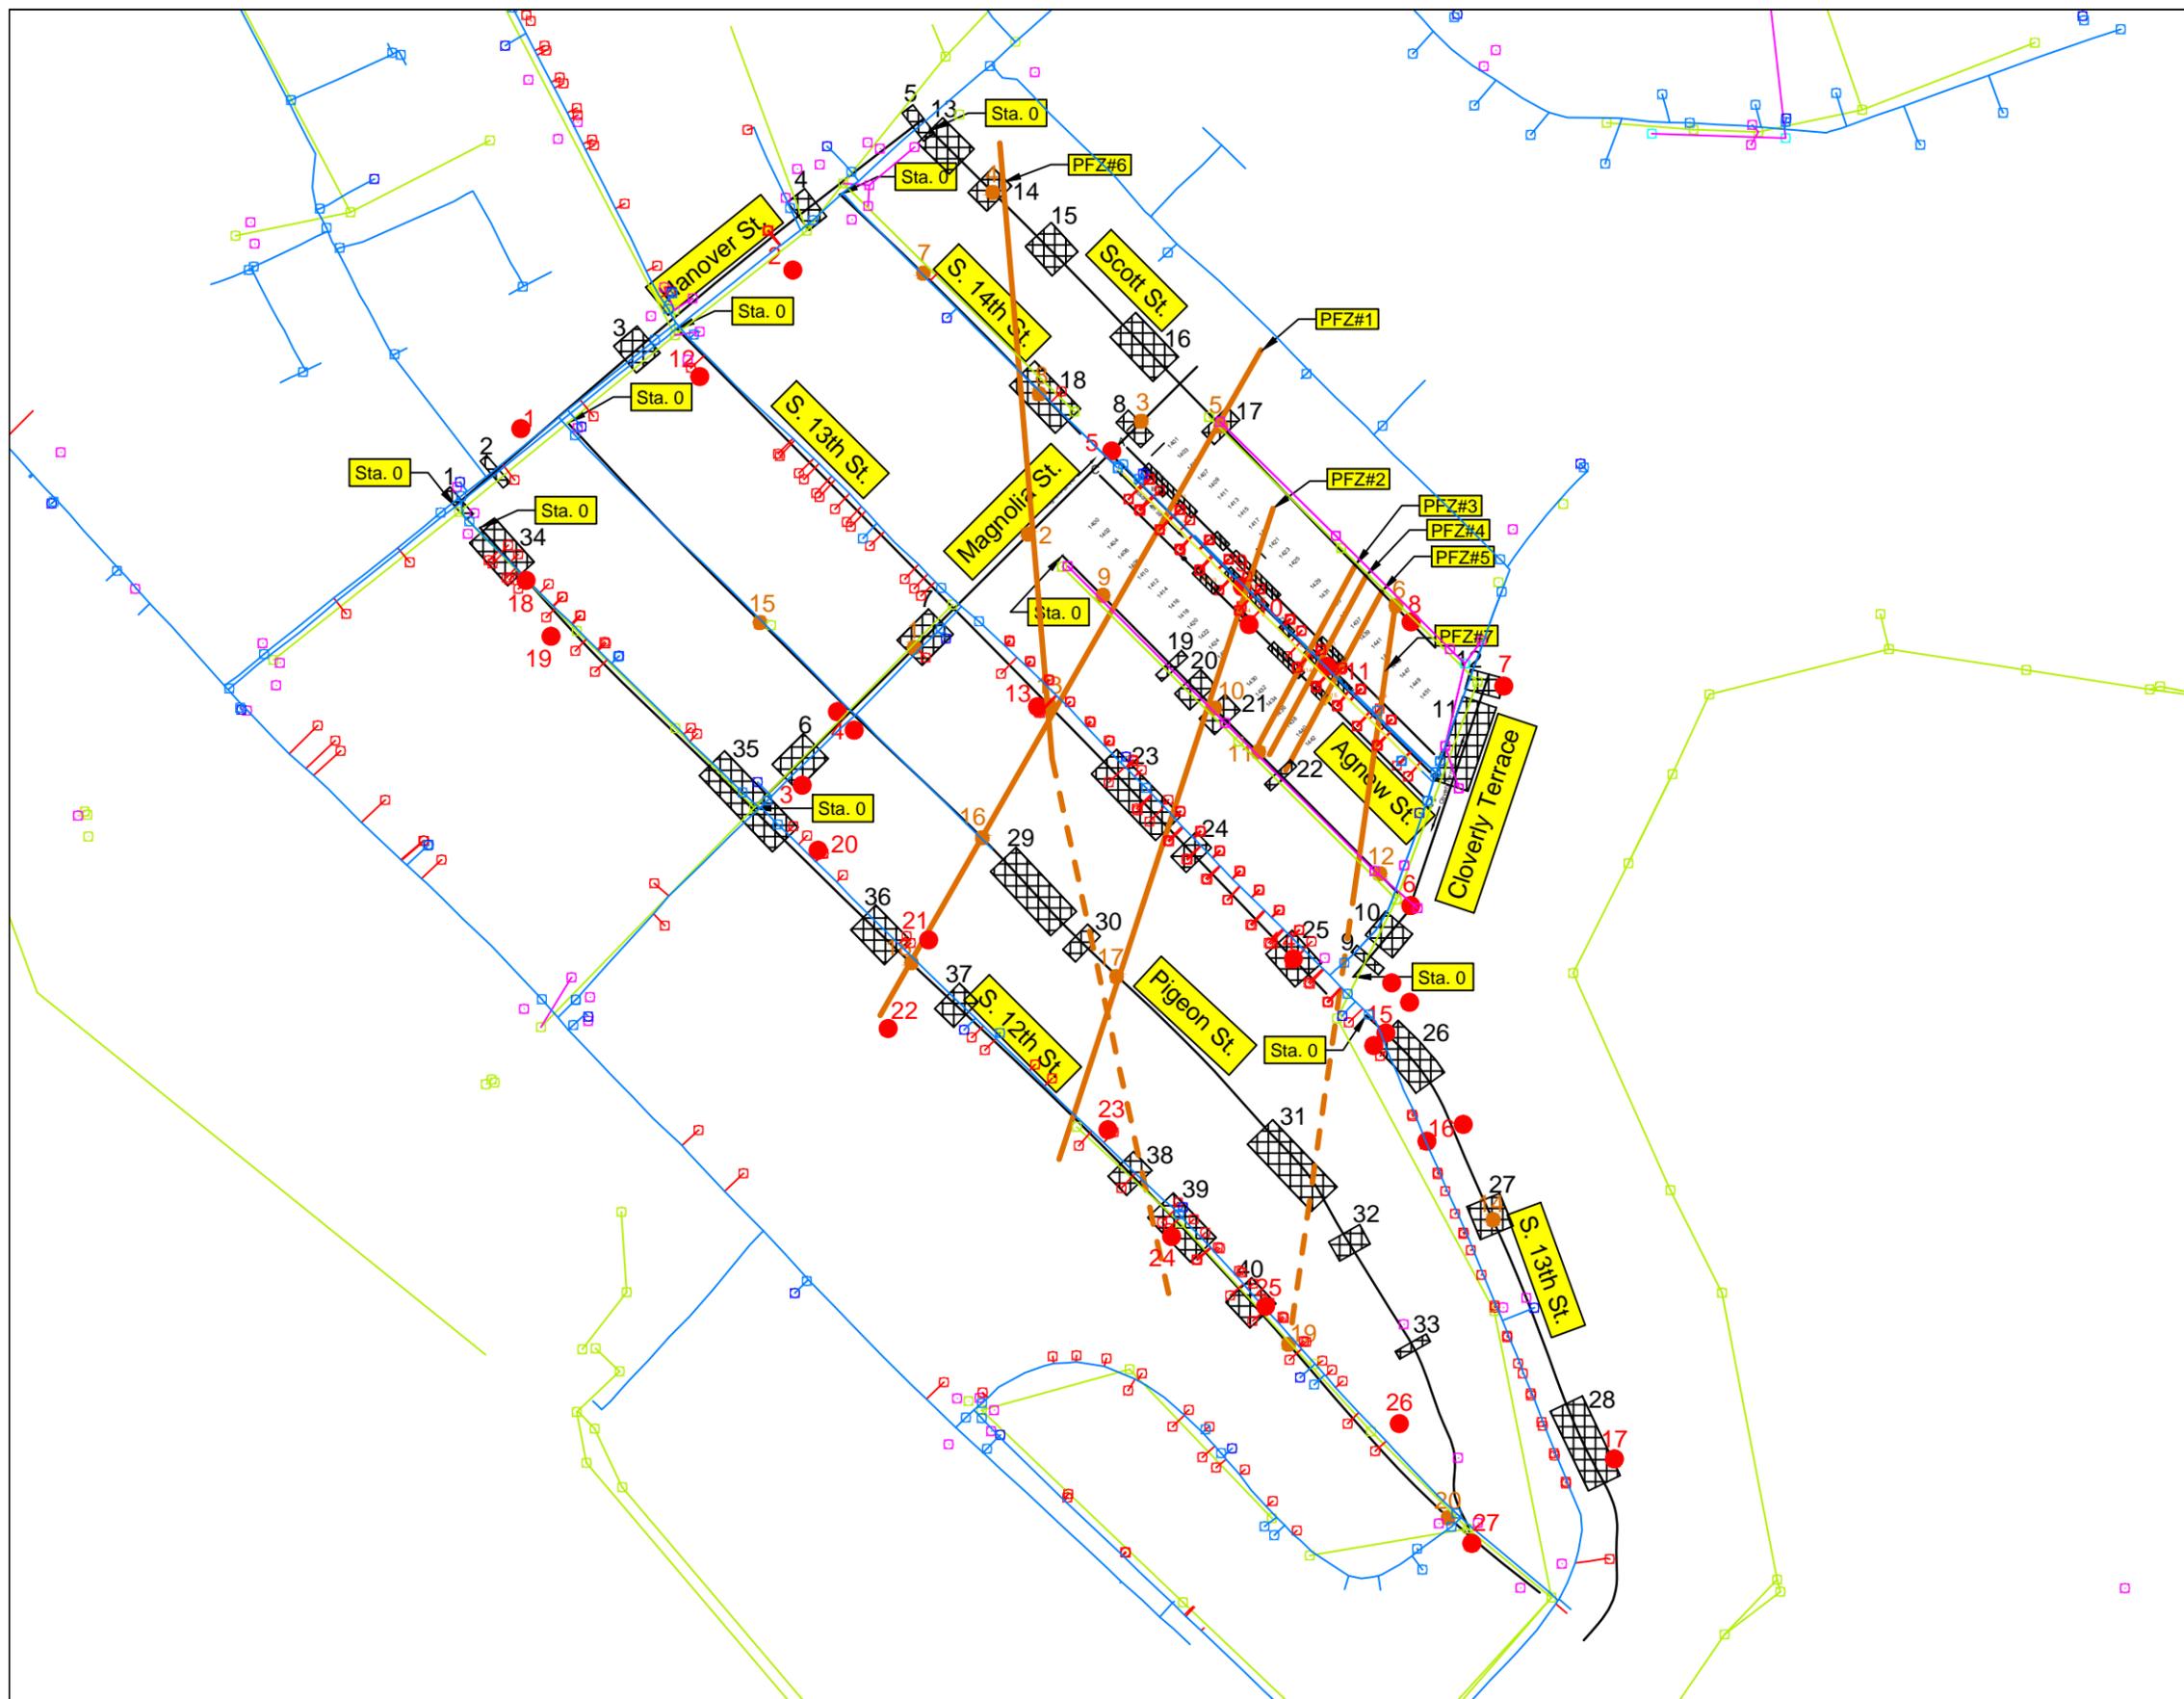
The location of water, sanitary and stormwater pipes are shown on Figures 14A and 14B. Figure 14B is an overlay of the utility data on a line diagram of the geophysical findings. Many of the subsurface features identified by the MASW survey (potential voids or fracture-like anomalies) and all of the surface features are in the vicinity of one or more underground utility facilities. However, subsurface features were also identified along roadways with no utilities, such as Scott Street between Hanover Street and Magnolia Street, and most of Pigeon Street between Magnolia Street and S. 12<sup>th</sup> Street. Additionally, the site reconnaissance was performed along streets and sidewalks where the majority of utilities are located.

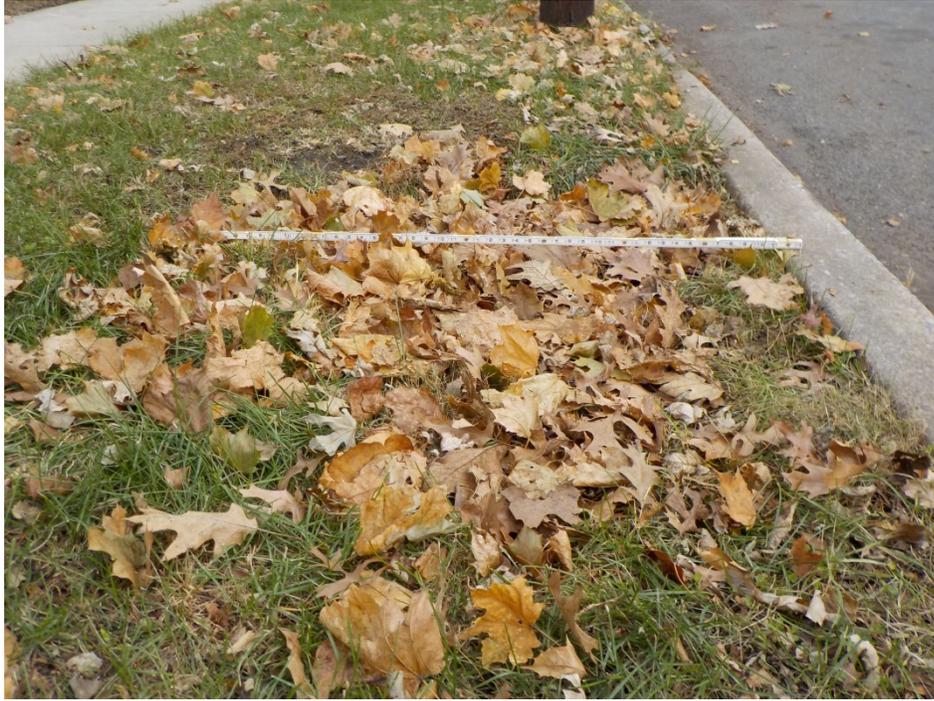
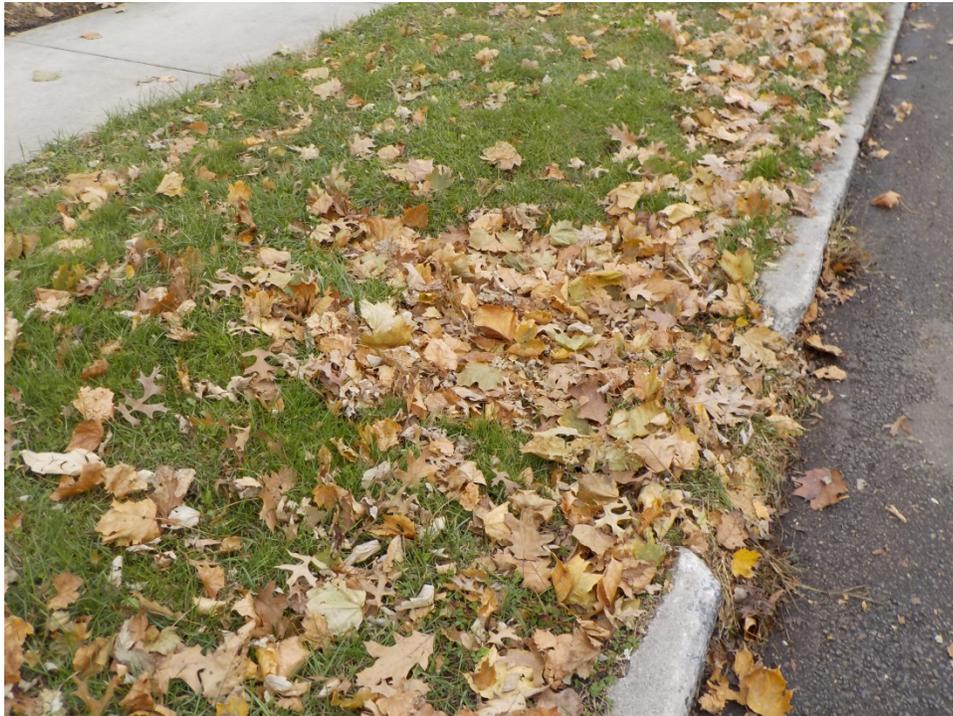
**Surface Feature 1**  
**Between Approximate Stations 100 and 150 Hanover Street**

Two Small Depressions in Lawn between Sidewalk and Street  
May be from Tree Removal

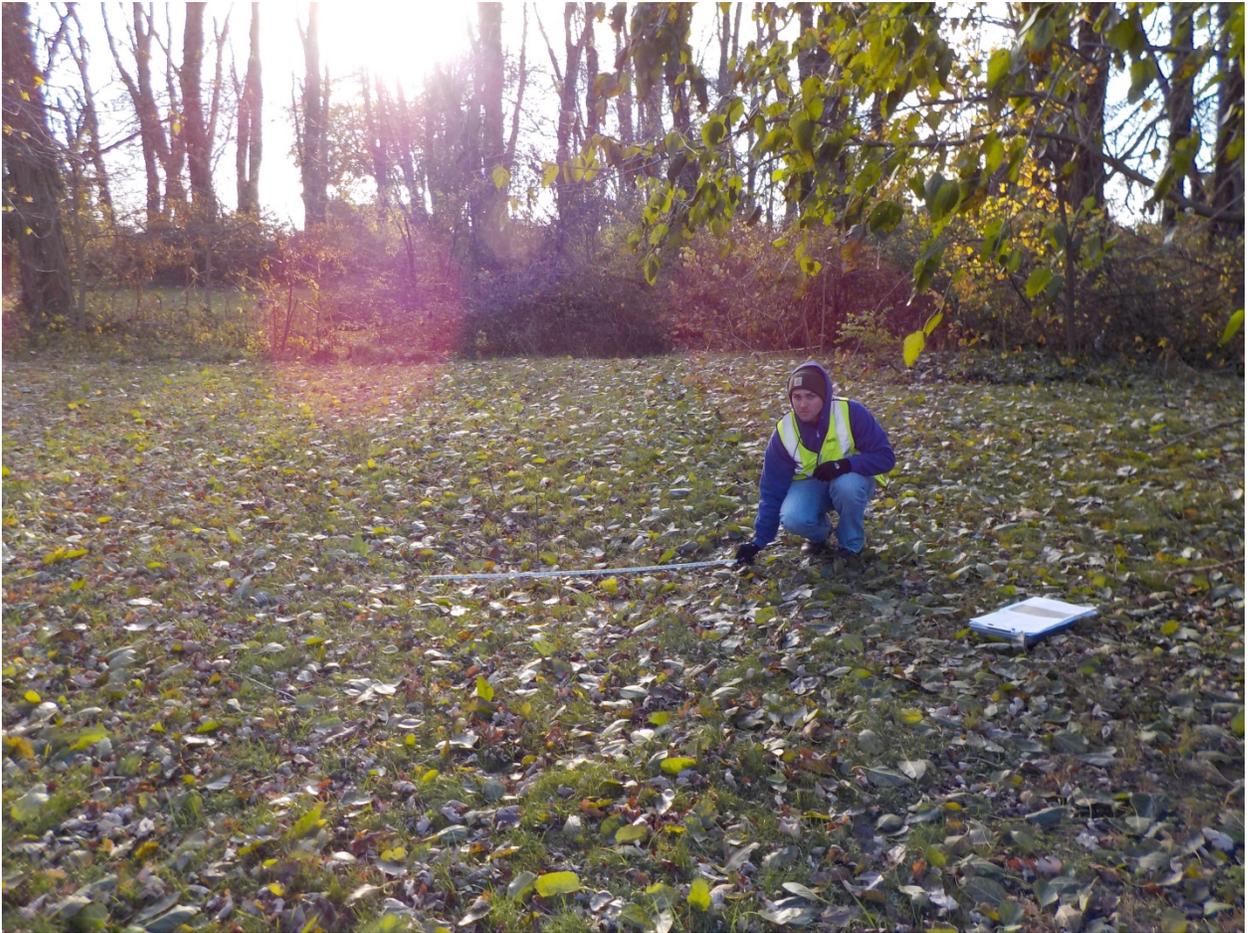
**Surface Feature 2**  
**Approximate Station 450 Hanover Street**

Possible Closed Depression in Open Area SE of Hanover Street

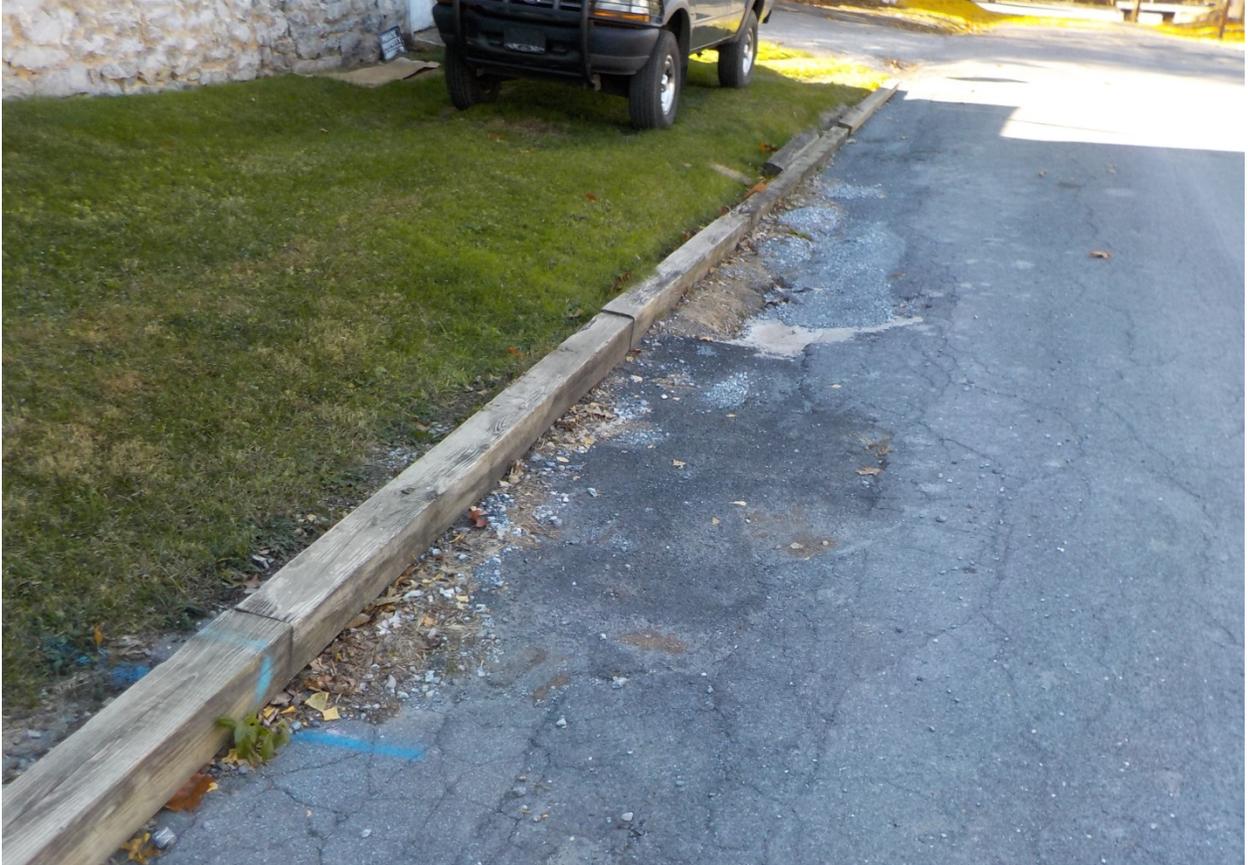
**Surface Feature 3**  
**Approximate Station 50 Magnolia Street**

Depression and Pavement Repairs along SE Curb Line of Magnolia Street

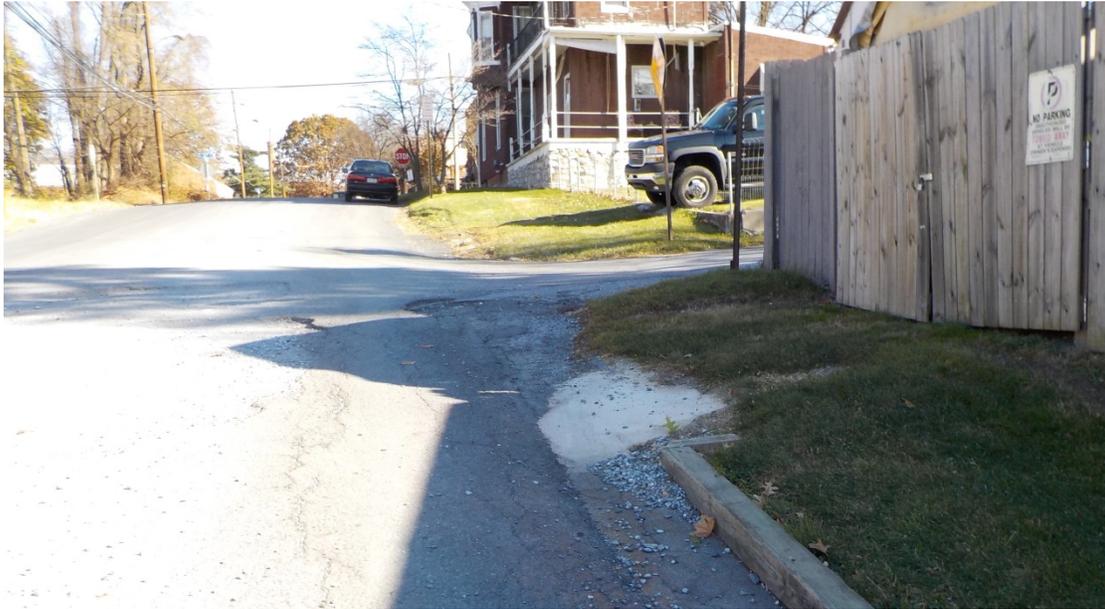
**Surface Feature 4**  
**Approximate Station 170 to 180 Magnolia Street**

Repair along SE Curb Line, Looking Ahead Station

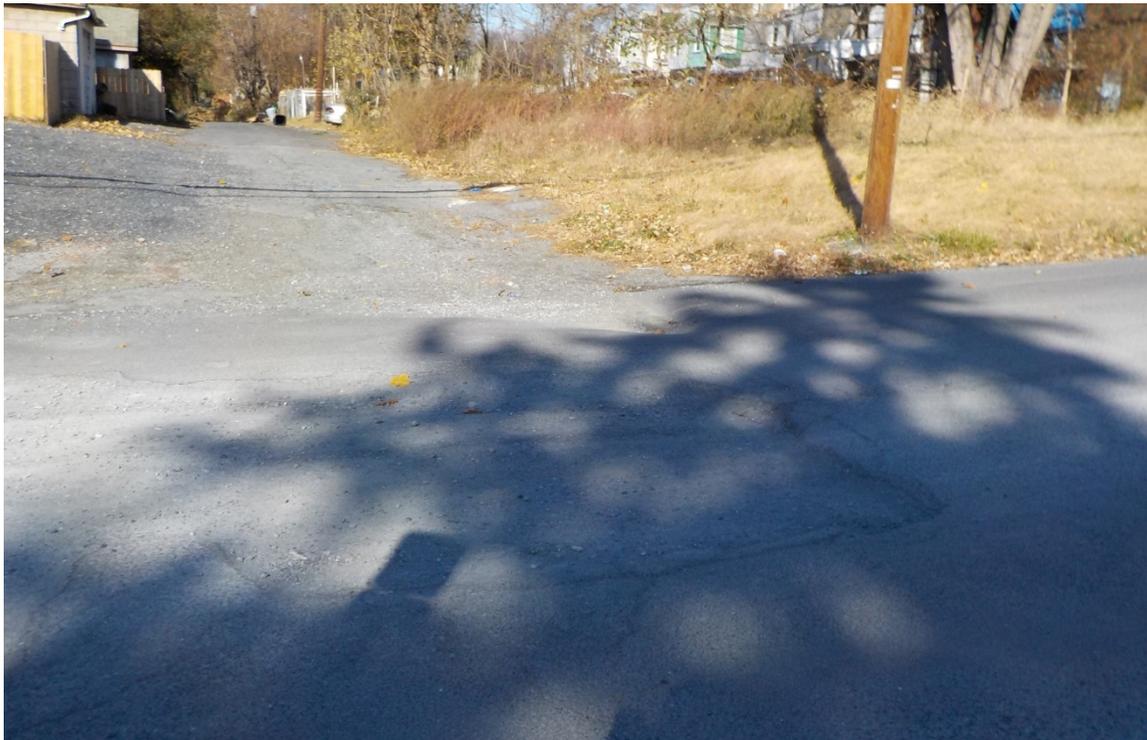
Pavement Cut Area with Depression Beyond, looking NW

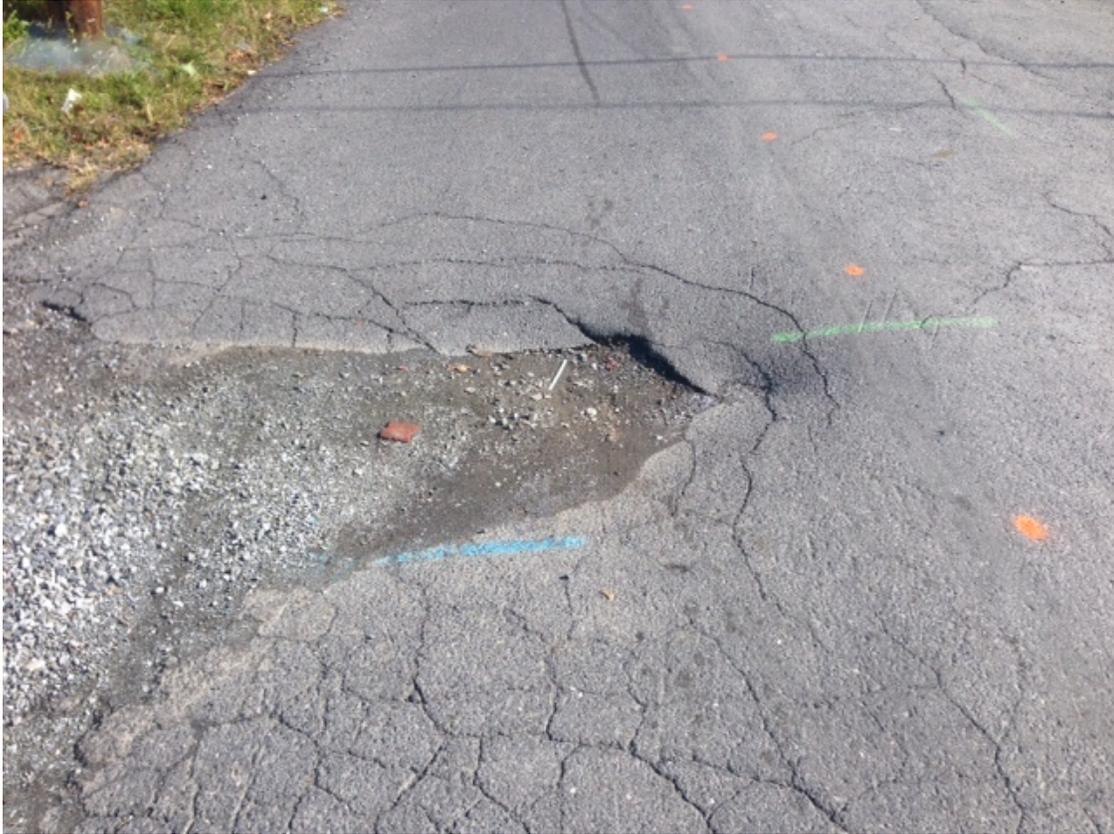
**Surface Feature 4**  
**Approximate Station 170 to 180 Magnolia Street**

Depression Looking Ahead Station

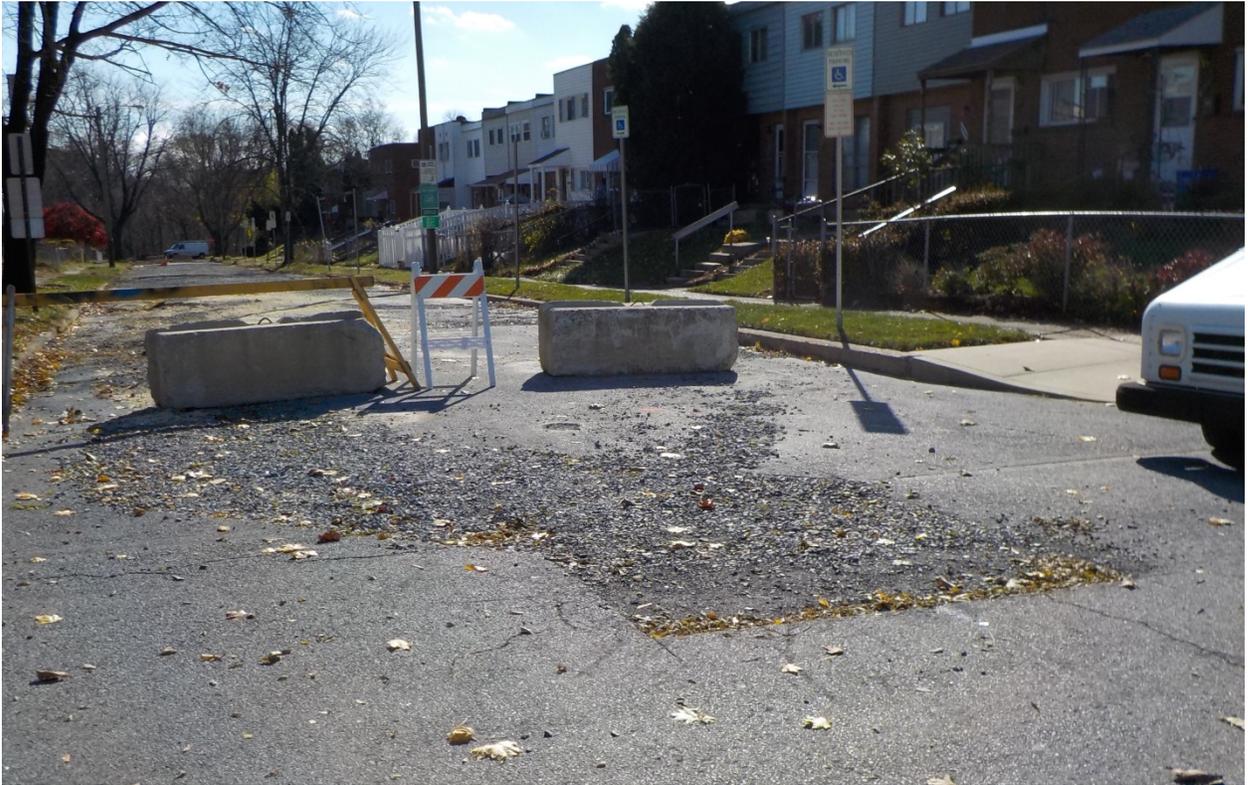
**Surface Feature 5**  
**Approximate Station 600 Magnolia Street**

Street Cuts and Exposed Aggregate Backfill Where New Water Line Work Along  
1400 Block of S. 14<sup>th</sup> Street Connected to Existing Line

- Patch pavement areas and seal the joint between the new and old pavement where excavation has been performed and aggregate is exposed. Pavement areas with aggregate exposed were identified along Magnolia Street at the location of Surface Features 3, 4, and 5.
- If the parking lot where Surface Feature 22 is located is City property, consider paving or performing the permeability reduction detail included in the Work Order # 3 Report (Gannett Fleming, October 2014).
- Prioritize the study area for inspection of water, stormwater and sanitary sewers to identify and replace deteriorated lines. Perform reconstruction or repairs incorporating the most watertight and flexible joints possible.

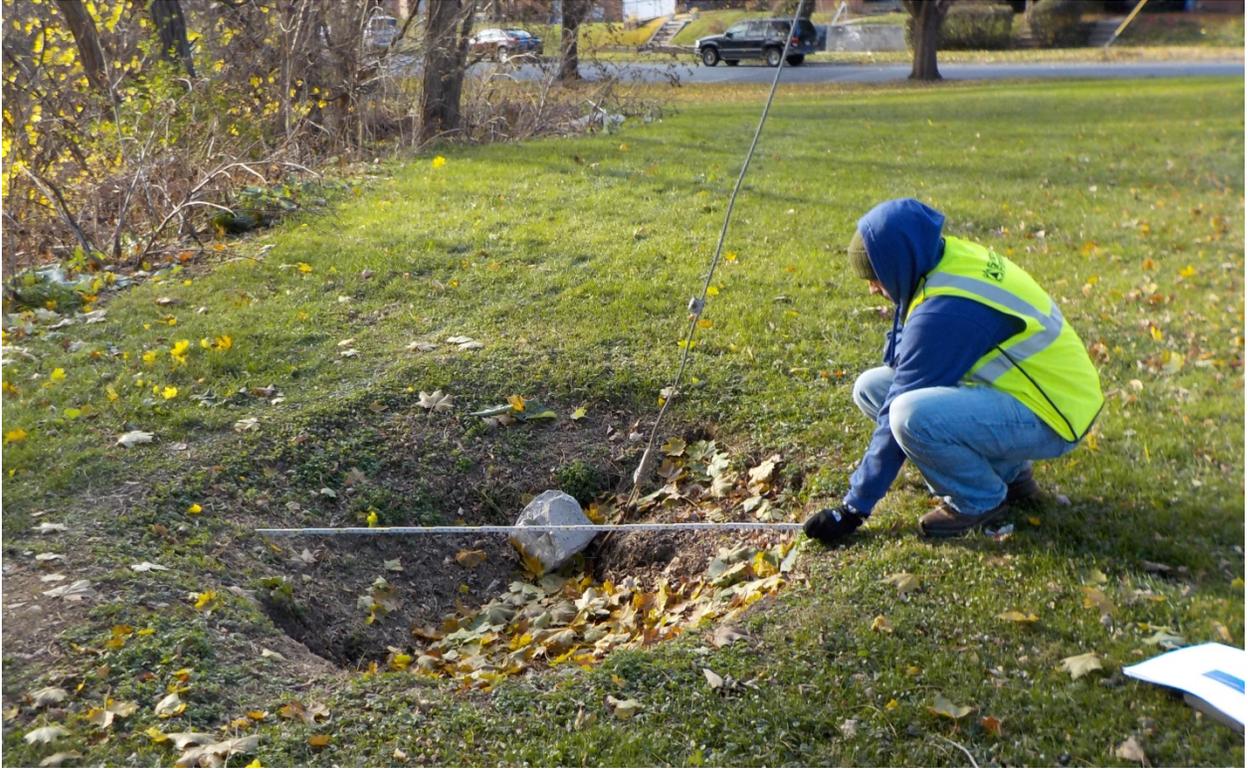
**Surface Feature 6**  
**Approximate Station 100 Cloverly Terrace**

Closed Depression on East Side of Cloverly Terrace  
Utility Pole Tiedown Shows Evidence of Extension  
SW Inlet Nearby

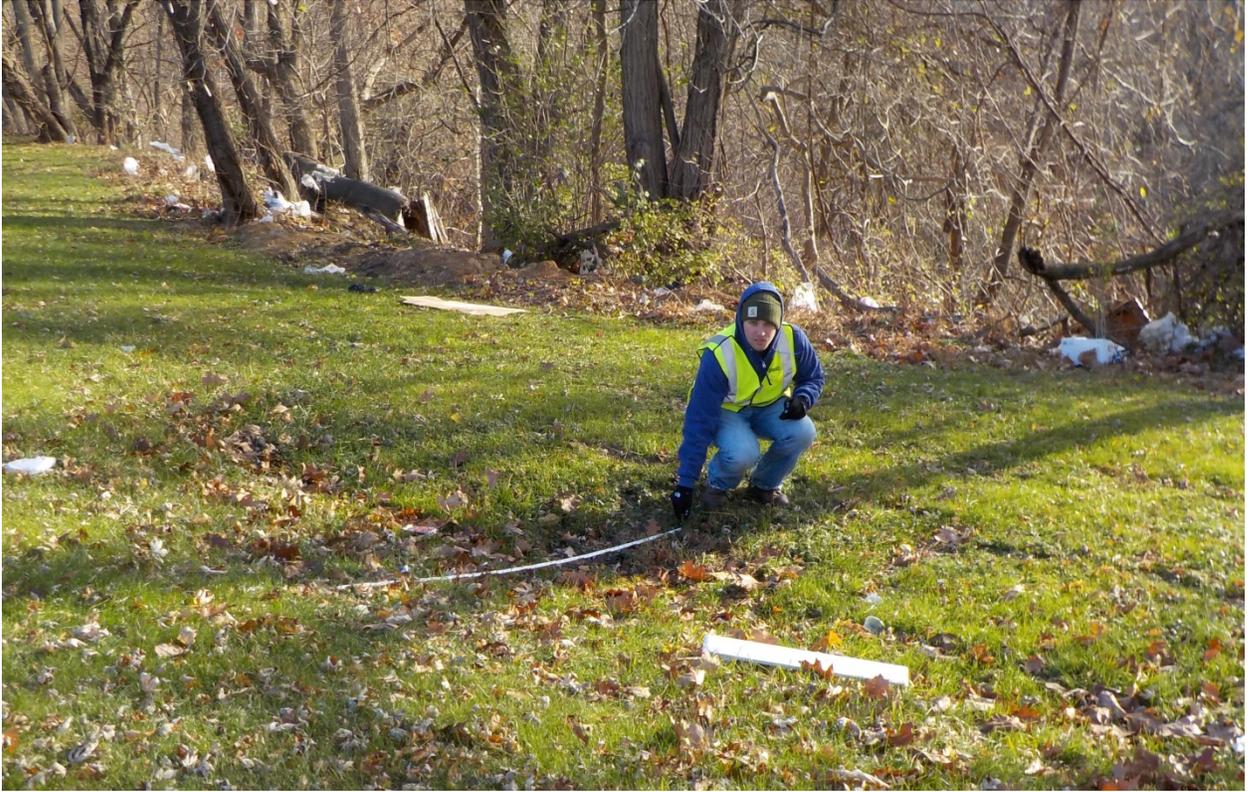
**Surface Feature 7**  
**Approximate Station 375 Cloverly Terrace**

Closed Depressions on East Side of Cloverly Terrace  
May be Due to Poor Fill Compaction

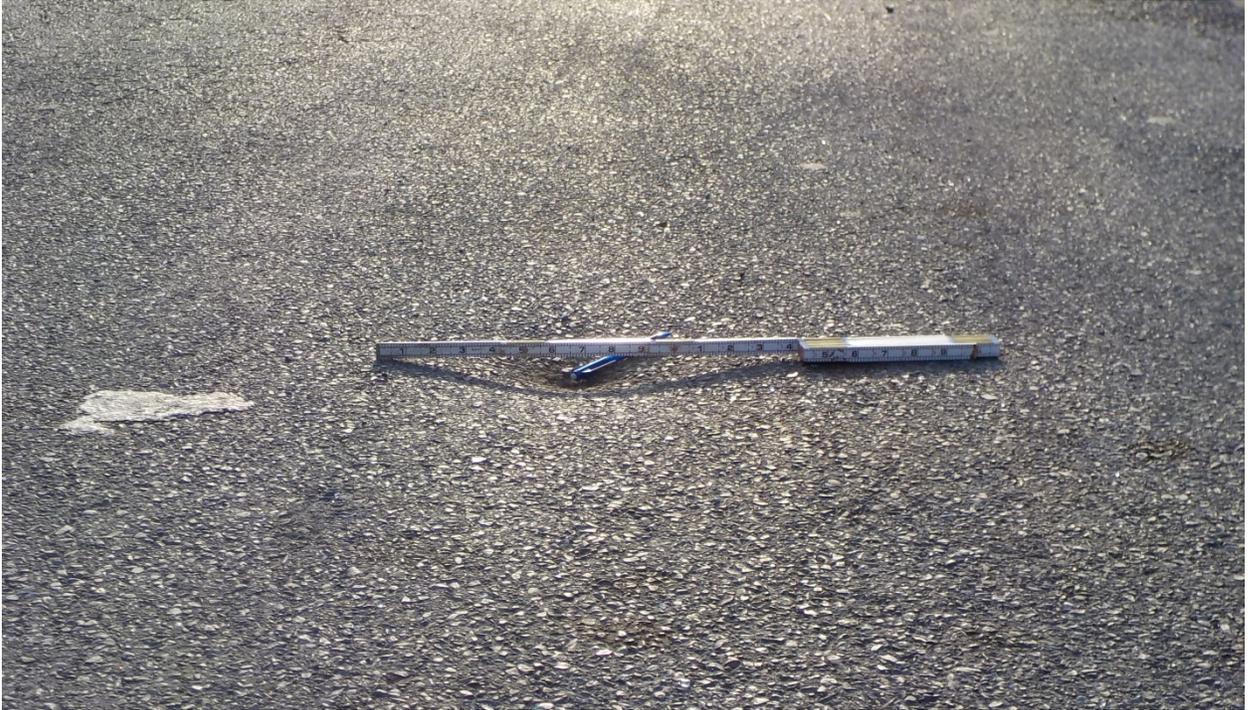
**Surface Feature 8**  
**Approximate Station 780 Scott Street**

Small Depression in Pavement

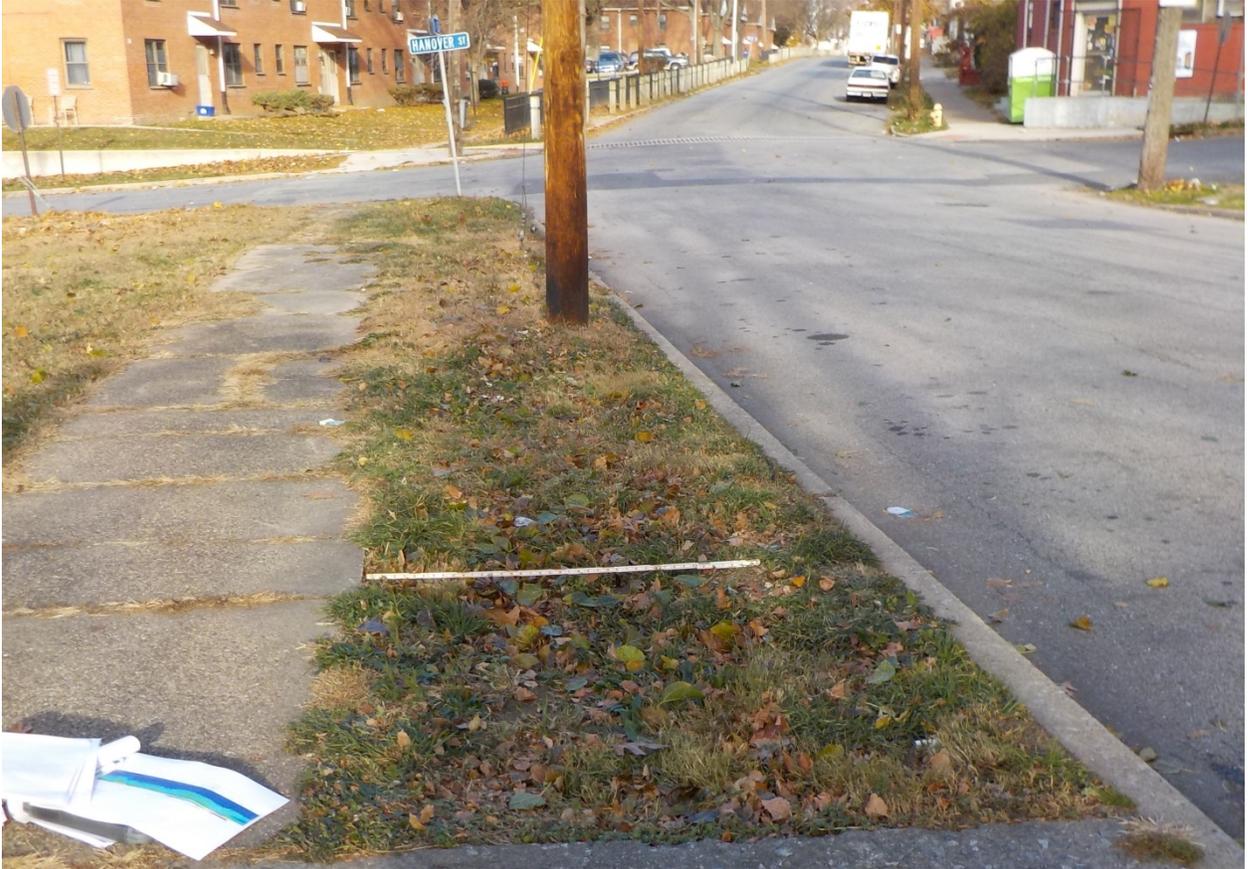
**Surface Feature 12**  
**Approximate Station 50 S. 13<sup>th</sup> Street (Hanover to Cloverly)**

Small Depression in Lawn between Sidewalk and Street  
May be from Tree Removal

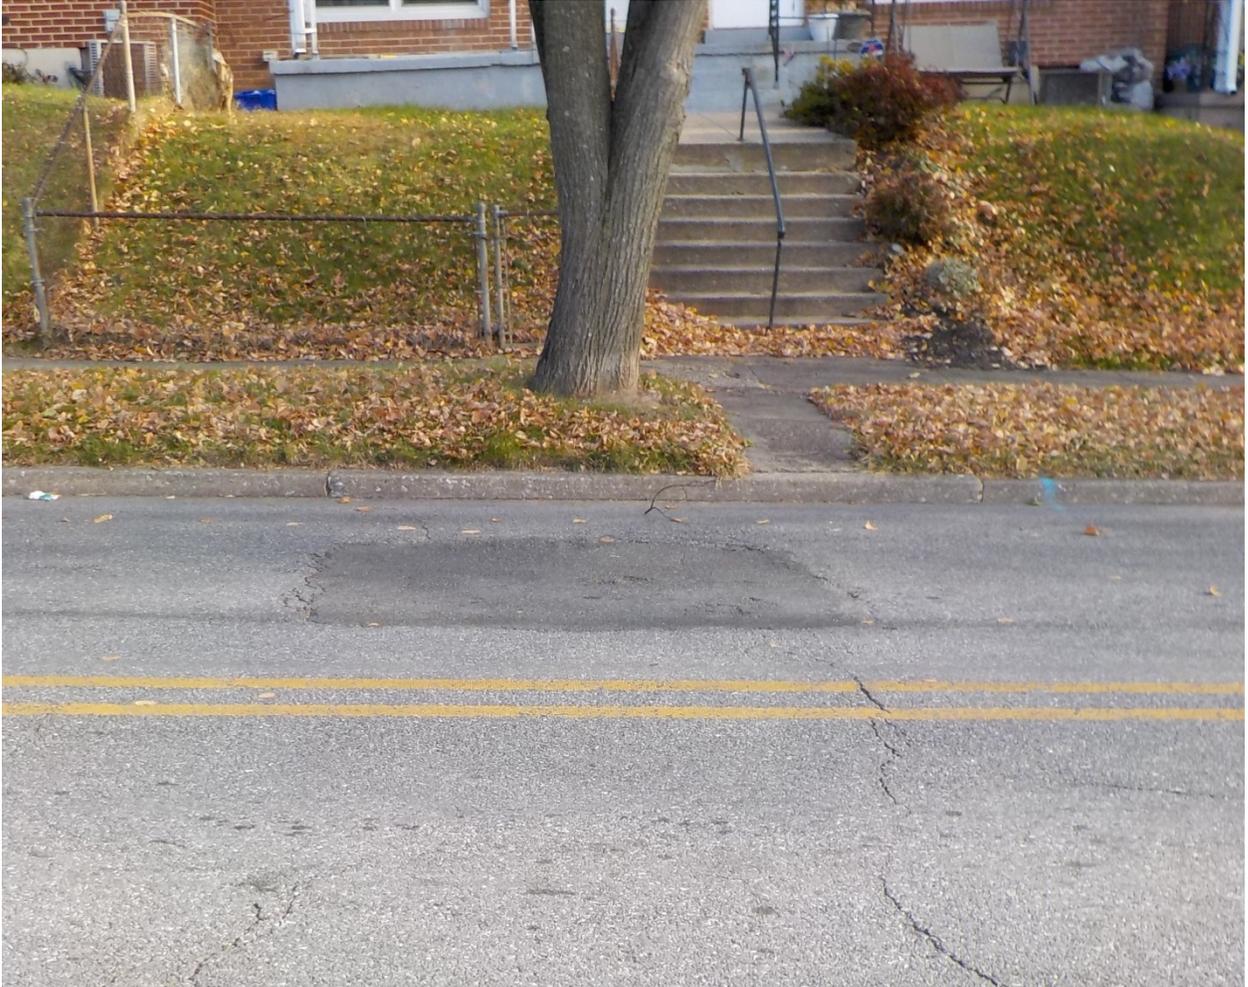
**Surface Feature 13**  
**Approximate Station 600 S. 13<sup>th</sup> Street (Hanover to Cloverly)**

Pavement Patch Located at Approximate Location of Potential Fracture Identified by MASW

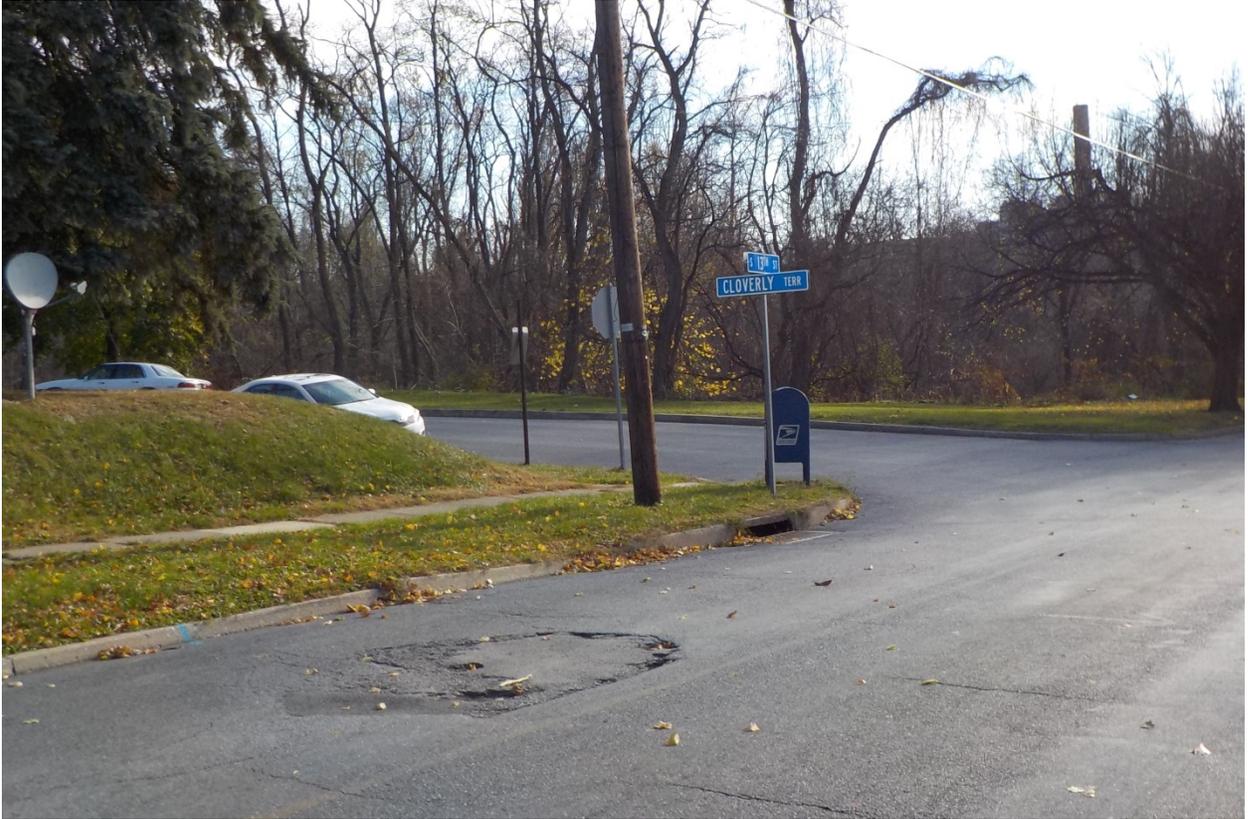
**Surface Feature 14**  
**Approximate Station 1000 S. 13<sup>th</sup> Street (Hanover to Cloverly)**

Pavement Patch Located at Approximate Location of Potential Void Identified by MASW

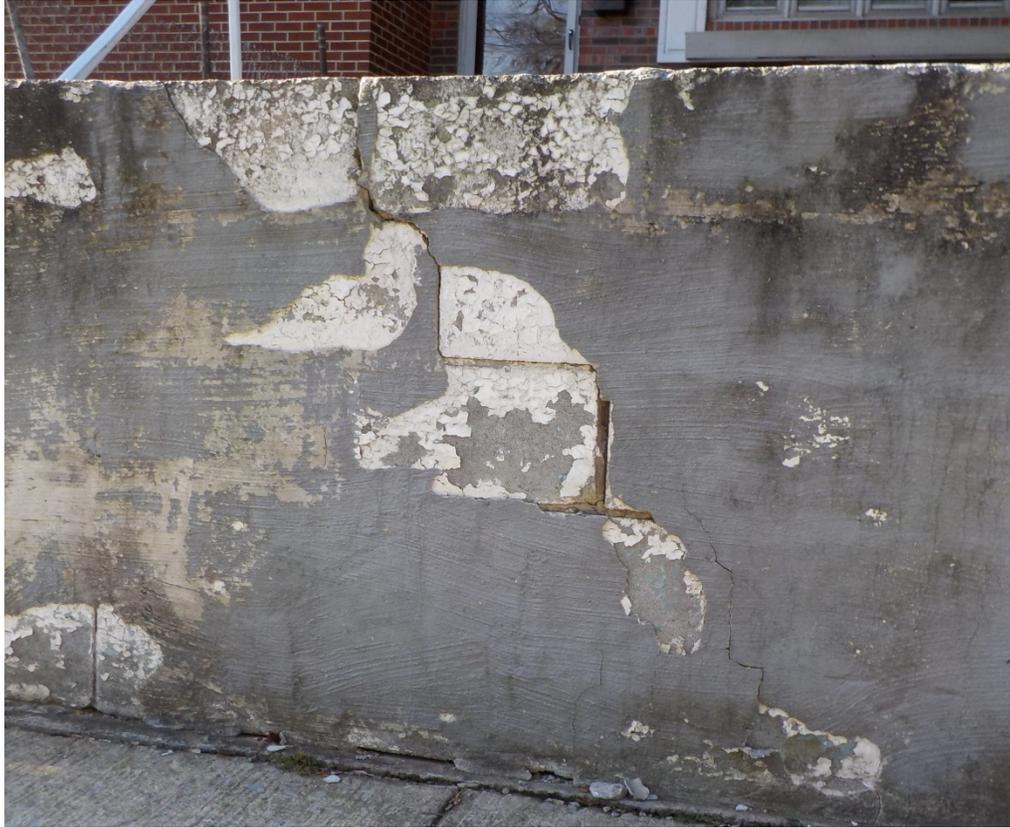
**Surface Feature 15**  
**Approximate Station 50 S. 13<sup>th</sup> Street (Cloverly to S. 12<sup>th</sup>)**

Crack in Retaining Wall S of 13<sup>th</sup> Street
