# **SOUTH HARRISBURG SINKHOLE EVALUATION WORK ORDER # 2**

## **HARRISBURG, PA**

**November 2014**

**Project Number: 59166**

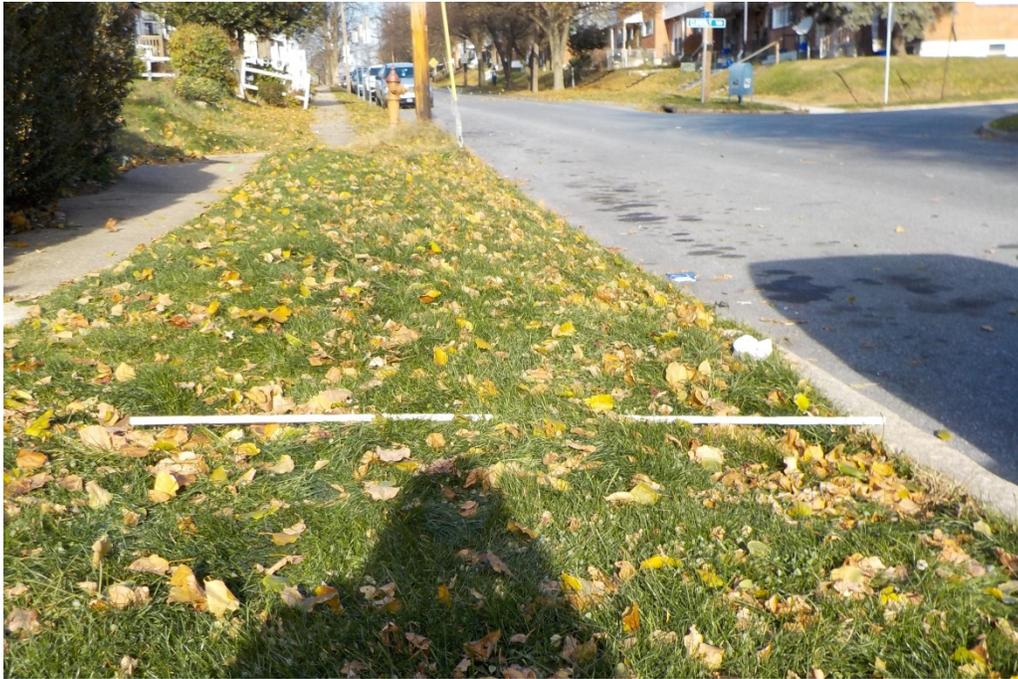
**Surface Feature 15**  
**Approximate Station 50 S. 13<sup>th</sup> Street (Cloverly to S. 12<sup>th</sup>)**

Closed Depression in Lawn between Sidewalk and Street Adjacent to Retaining Wall

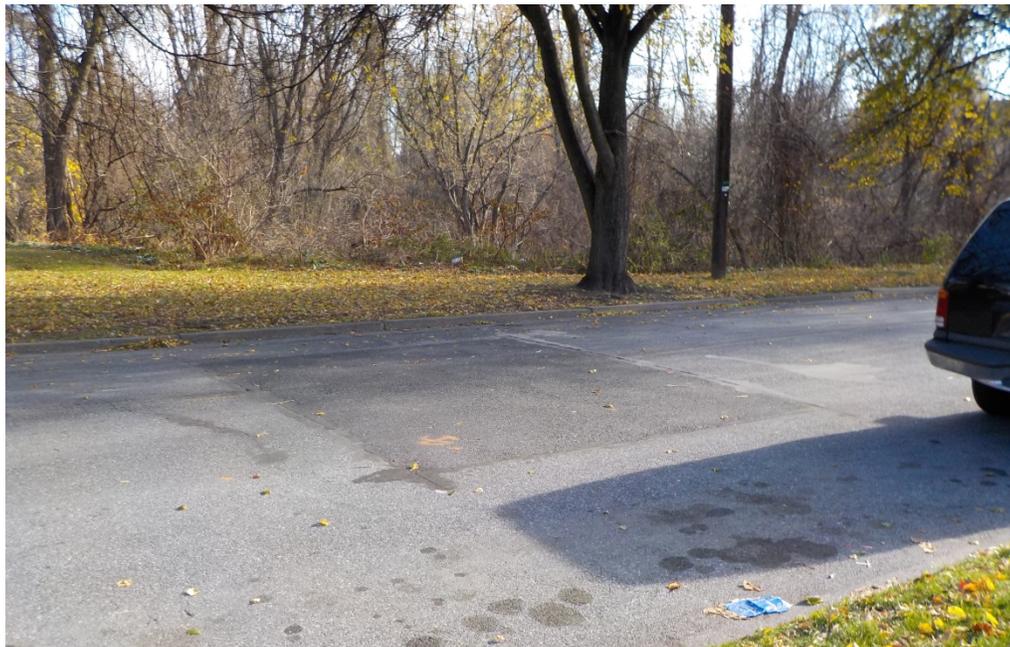
Pavement Patch Across from Lawn Depression and Cracked Retaining Wall

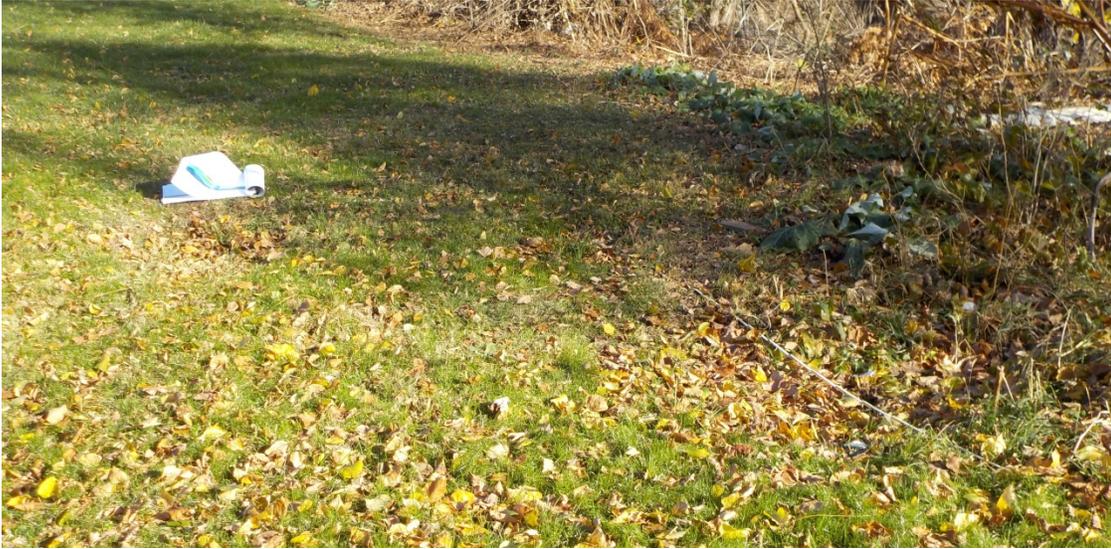
**Surface Feature 15**  
**Approximate Station 50 S. 13<sup>th</sup> Street (Cloverly to S. 12<sup>th</sup>)**

Closed Depressions in Grassy Area on N Side of 13<sup>th</sup> Street Across From Pavement Patch, Lawn Depression and Cracked Retaining Wall

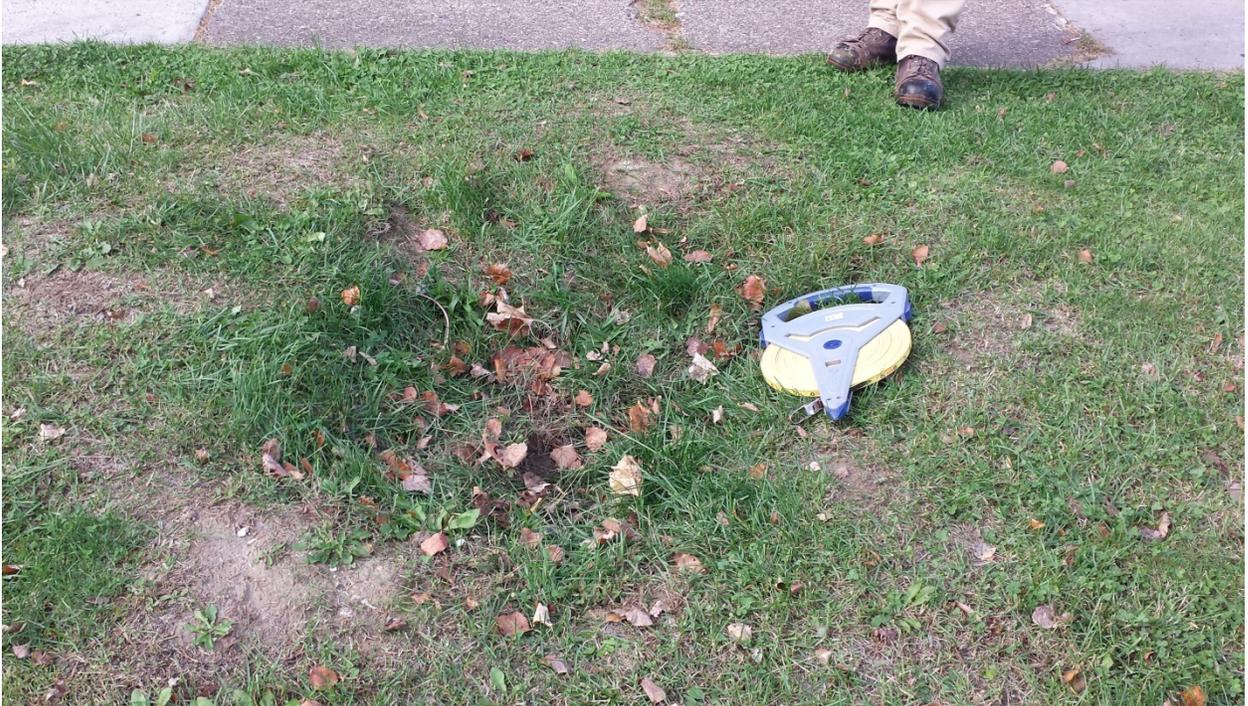
**Surface Feature 16**  
**Approximate Station 150 S. 13<sup>th</sup> Street (Cloverly to S. 12<sup>th</sup>)**

Depression Located Just Inside the Curb

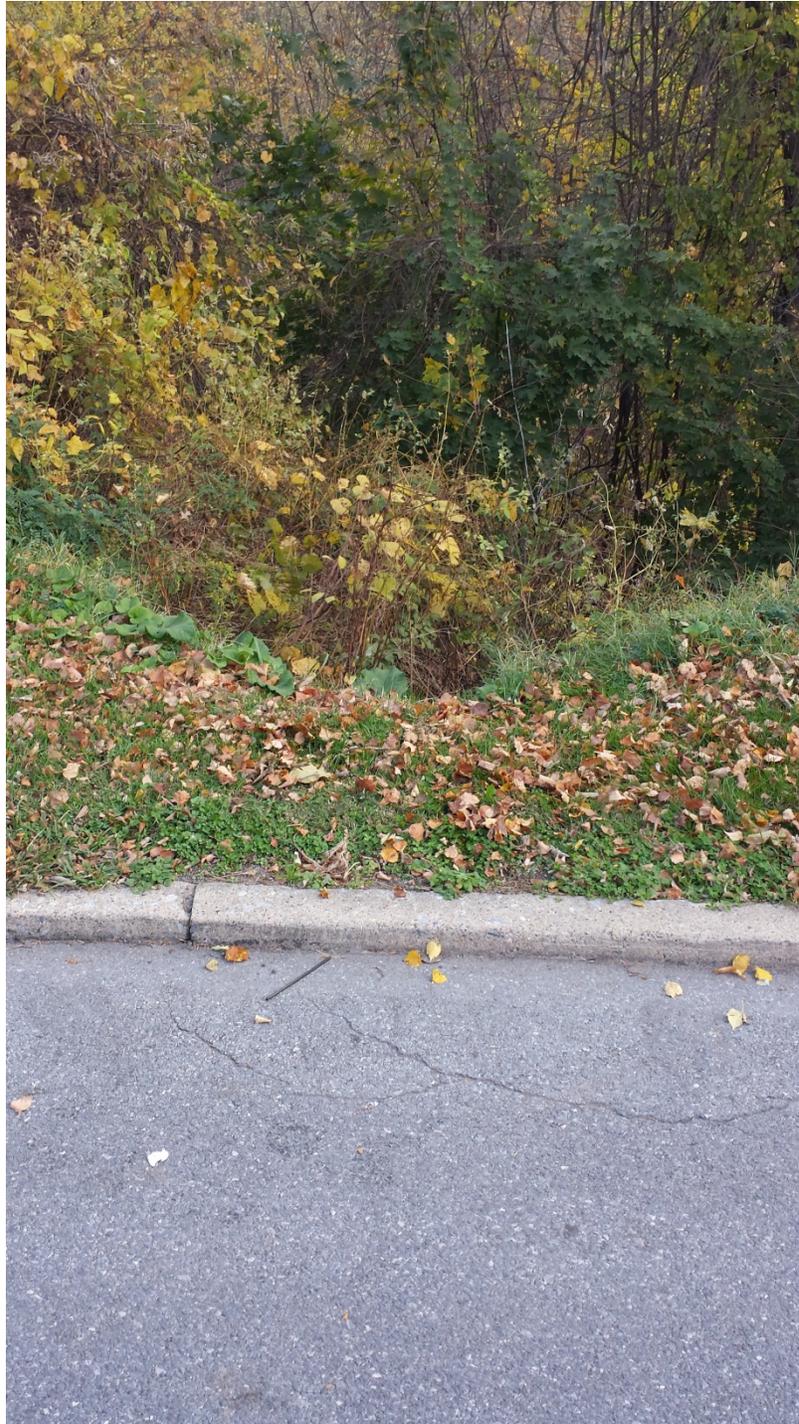
**Surface Feature 16**  
**Approximate Station 150 S. 13<sup>th</sup> Street (Cloverly to S. 12<sup>th</sup>)**

Possible Slope Failure across Street from Depression

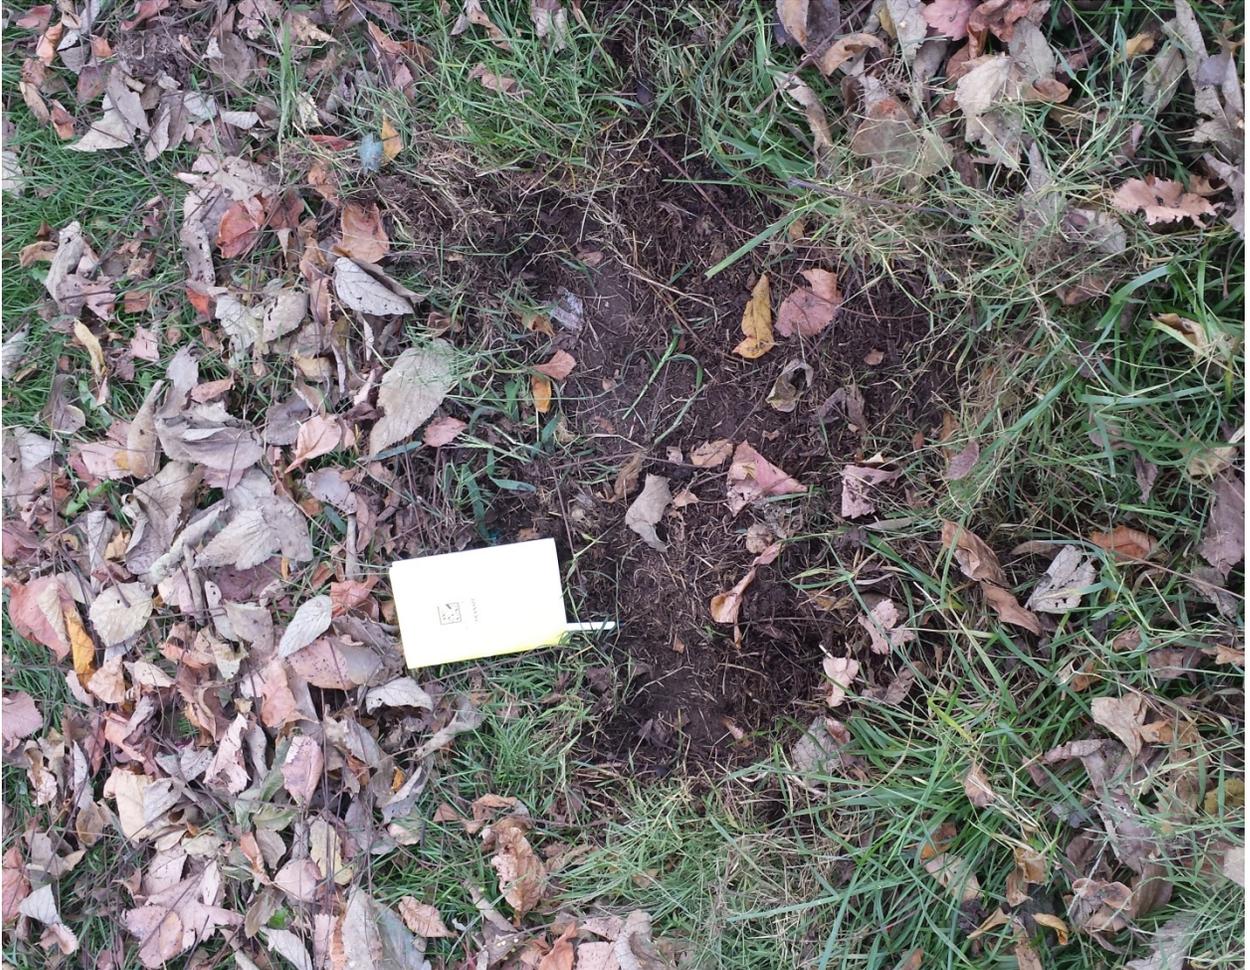
**Surface Feature 17**  
**Approximate Station 585 S. 13<sup>th</sup> Street (Cloverly to 12<sup>th</sup>)**

Depression Located 15 feet Behind Eastern Curb across Street from Homes

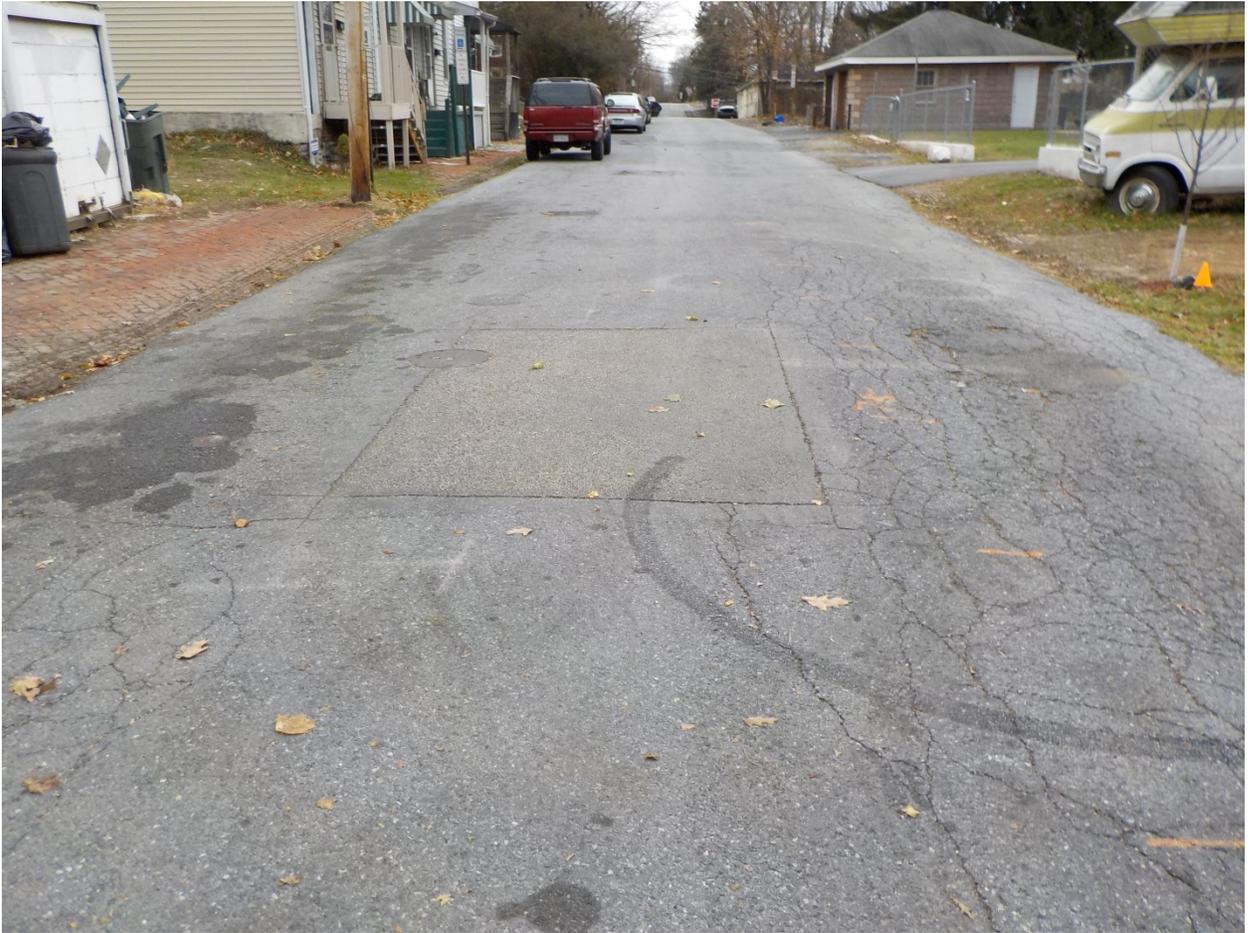
**Surface Feature 18**  
**Approximate Station 75 S. 12<sup>th</sup> Street**

Pavement Patch Located at Approximate Location of Potential Void Identified by MASW

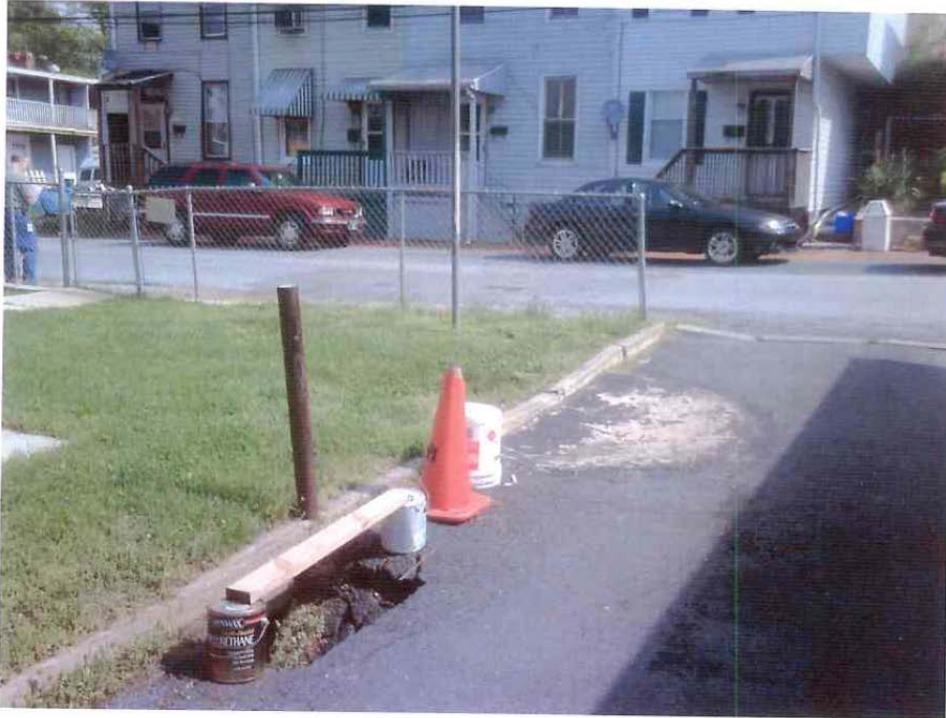
**Surface Feature 19**  
**Approximate Station 150 S. 12<sup>th</sup> Street**

Sinkhole Repaired by City (City Photo)

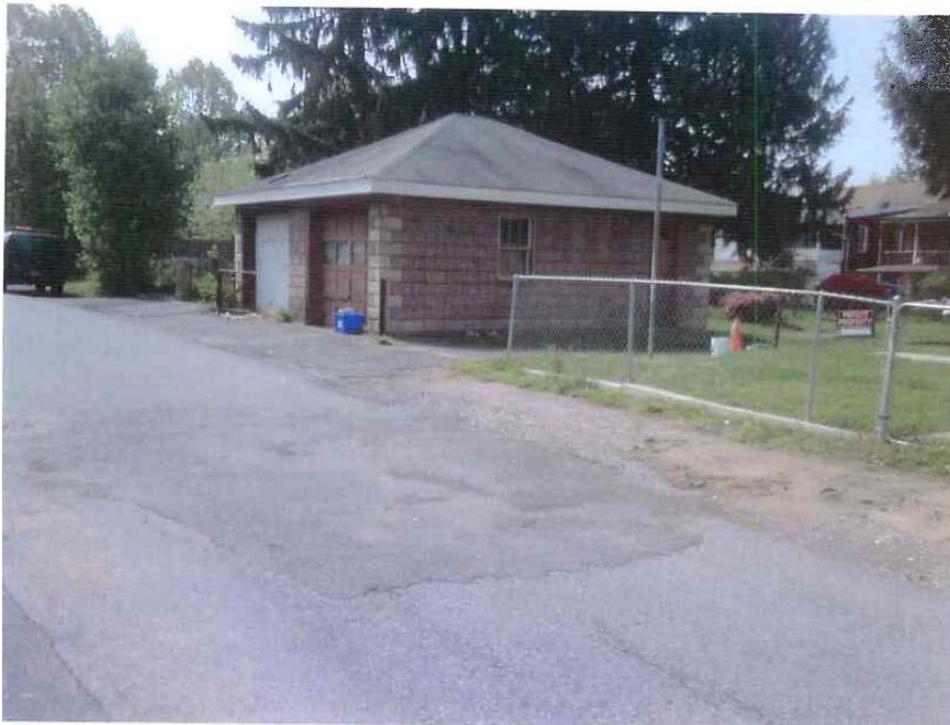
Driveway Patching Nearby (City Photo)  
**Surface Feature 20**  
Between Approximate Stations 500 to 550 S. 12<sup>th</sup> Street

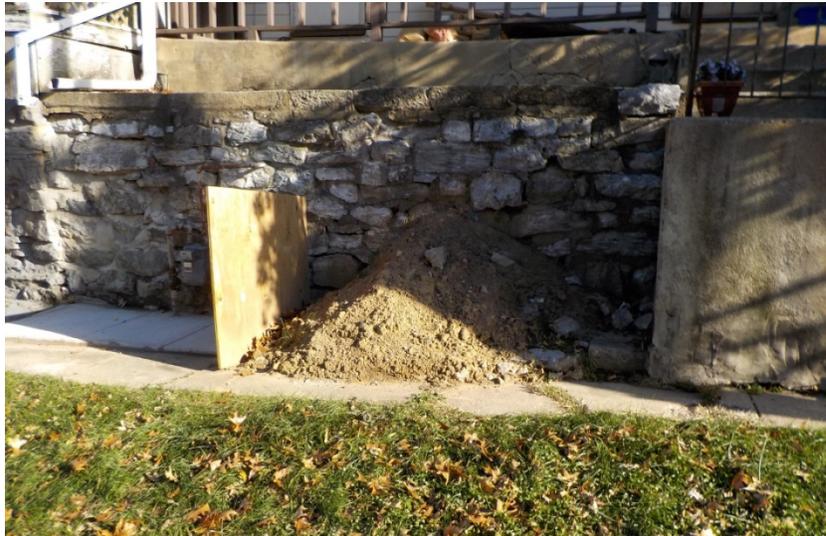
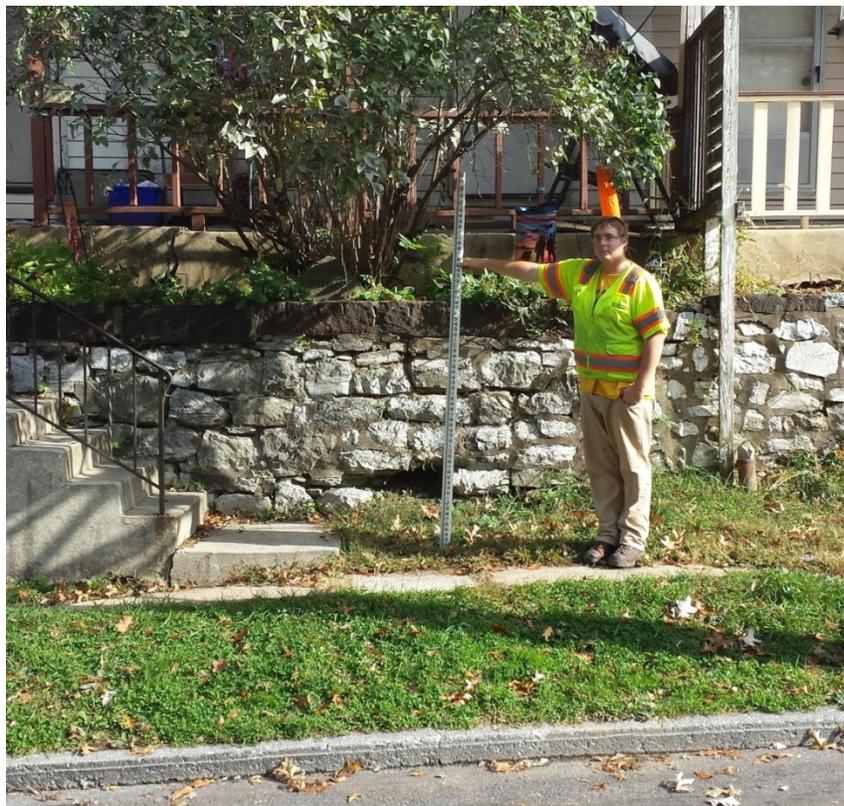
Masonry Retaining Wall in Front of 3 Row Homes on E Side of Street  
From Left to Right: Repair, Buttress by Soil Fill, and Undermined by Closed Depression

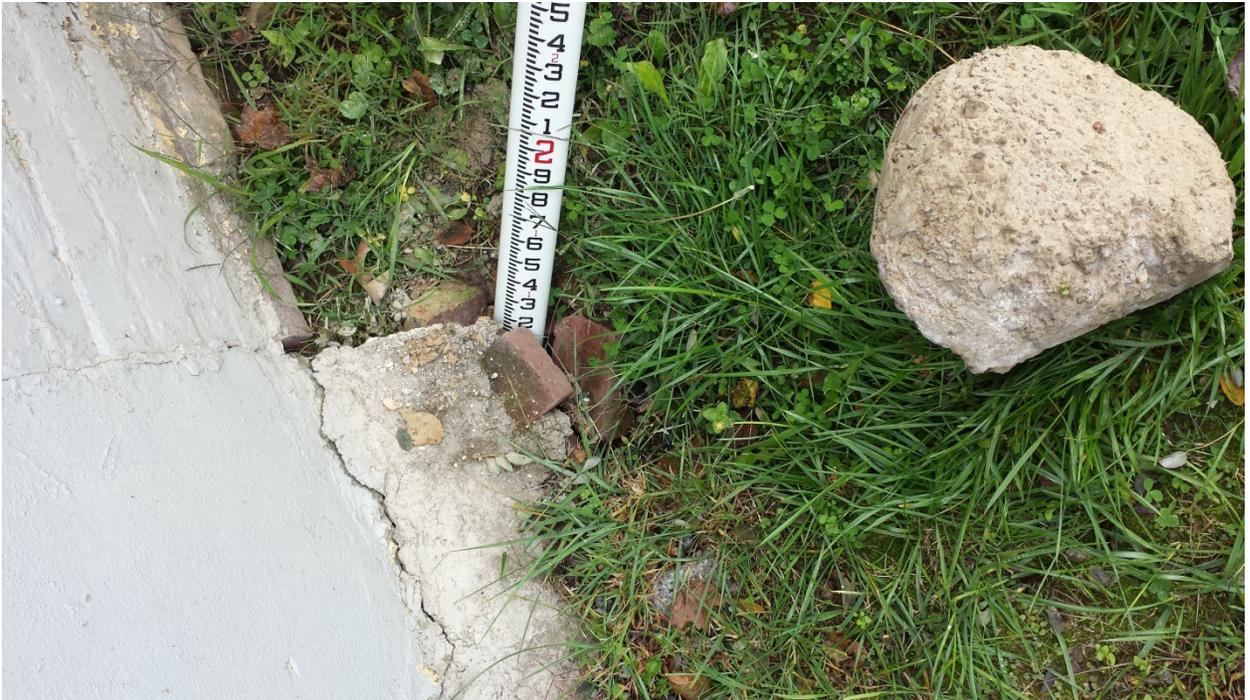
**Surface Feature 21**  
**Approximate Station 675 S. 12<sup>th</sup> Street**

Depression Under Porch Footing

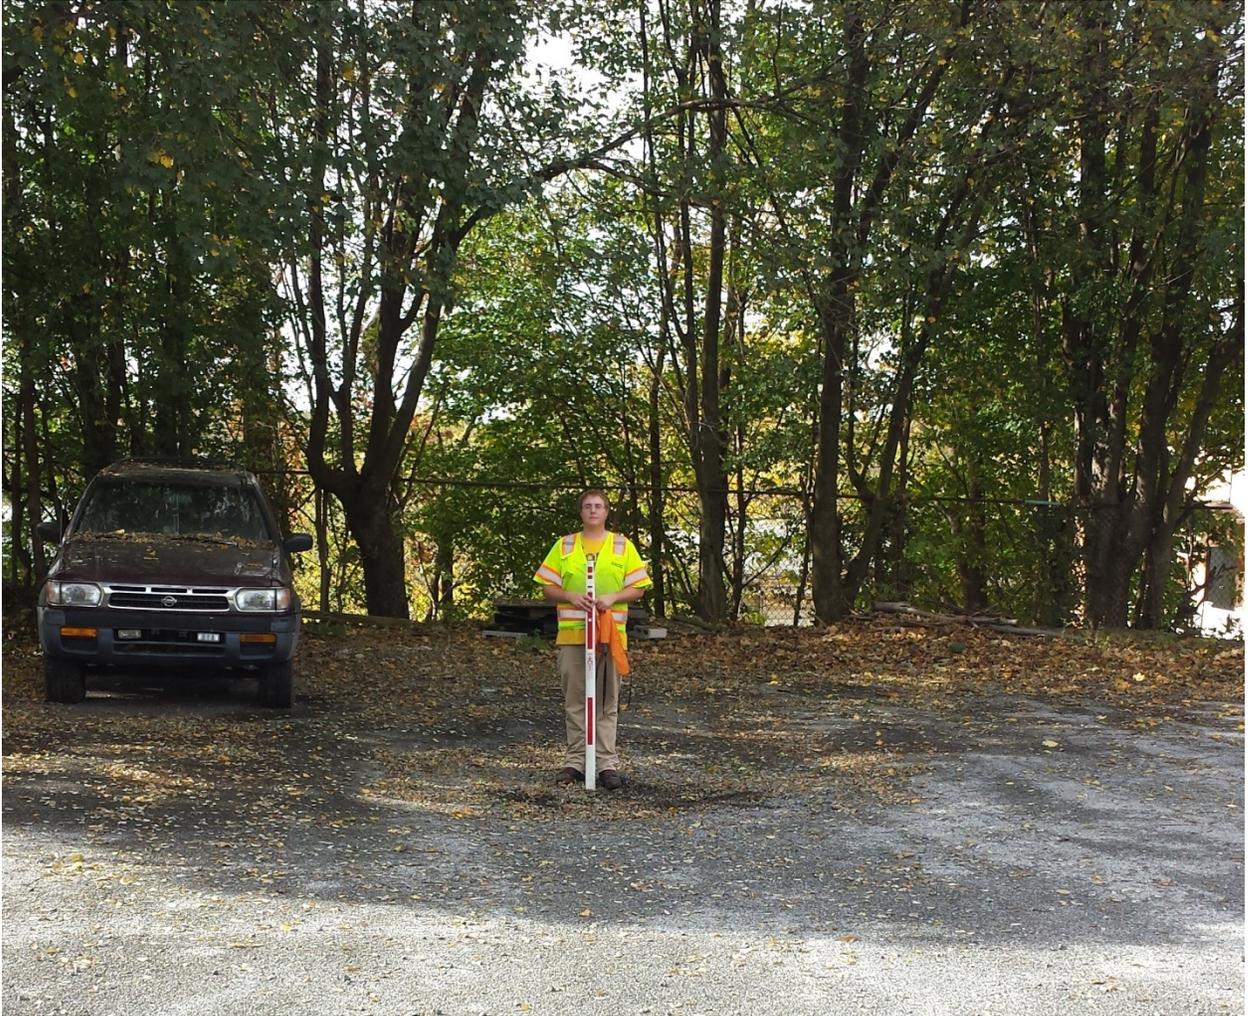
**Surface Feature 22**  
**Approximate Station 750, S. 12<sup>th</sup> Street**

Large Depression in Parking Area Next to House  
Appears to Have Been Filled with Gravel

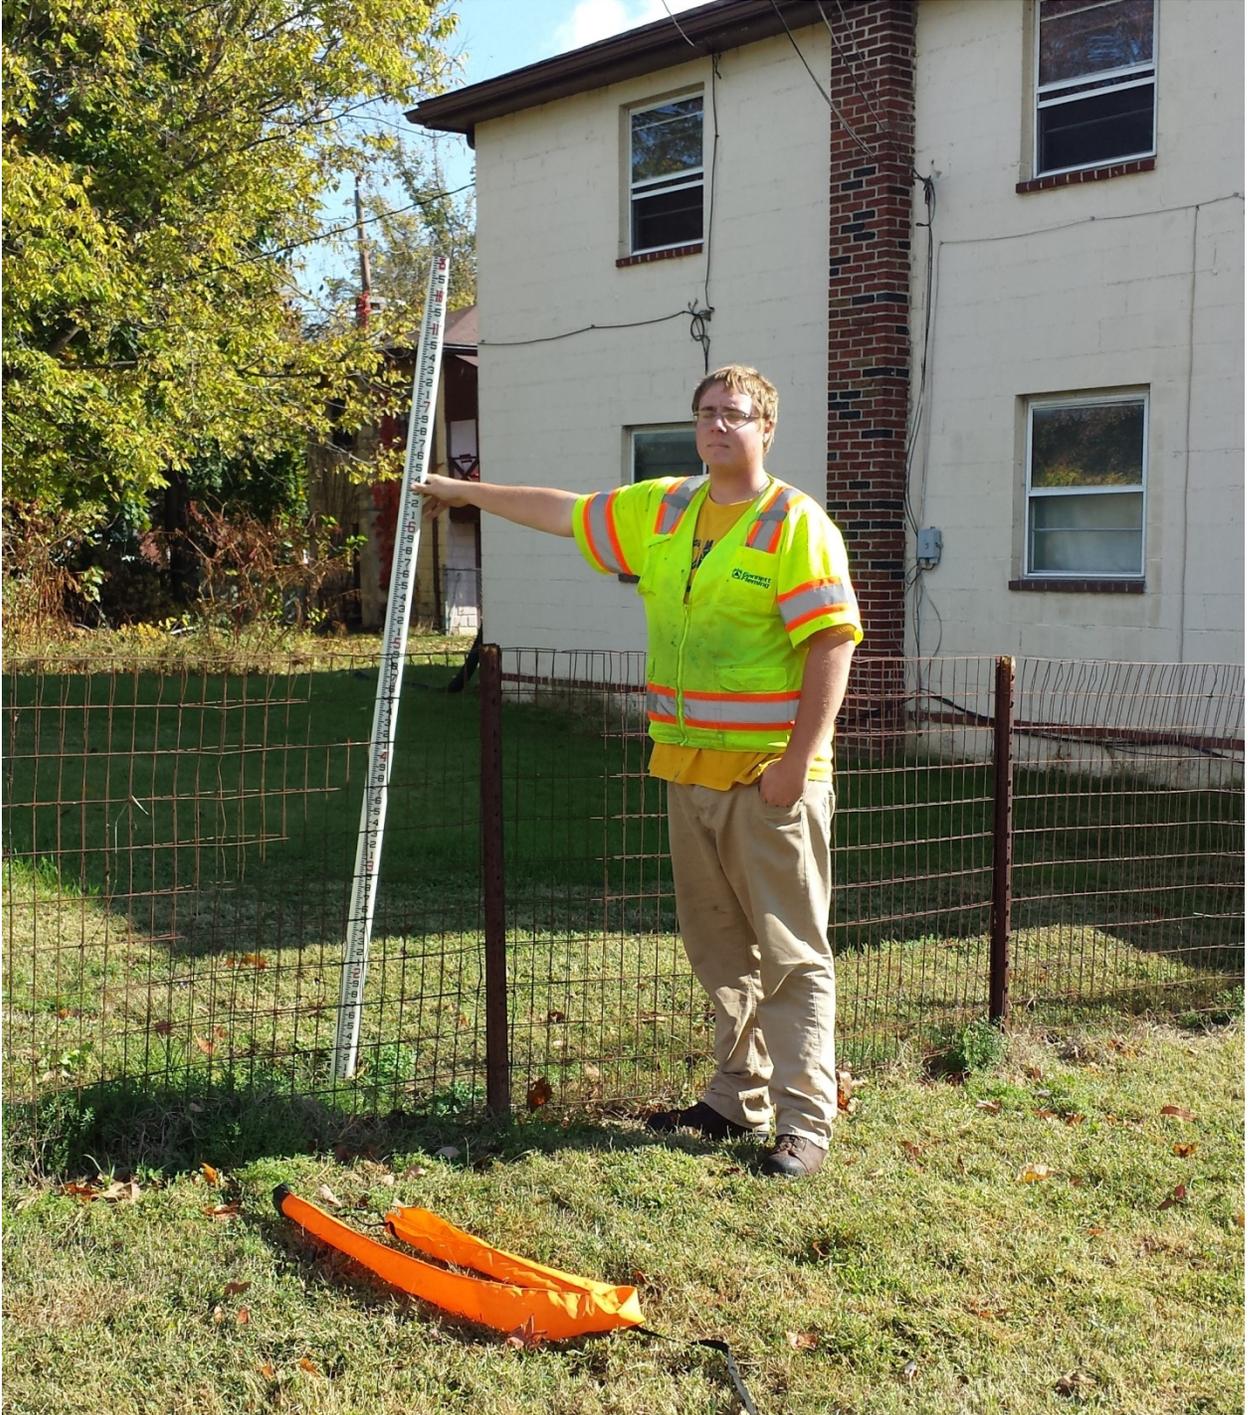
**Surface Feature 23**  
**Approximate Station 1000, S. 12<sup>th</sup> Street**

**Apparent Sinkhole in Yard**  
**Some Minor Depressions in Immediate Area Surrounding Sinkhole**

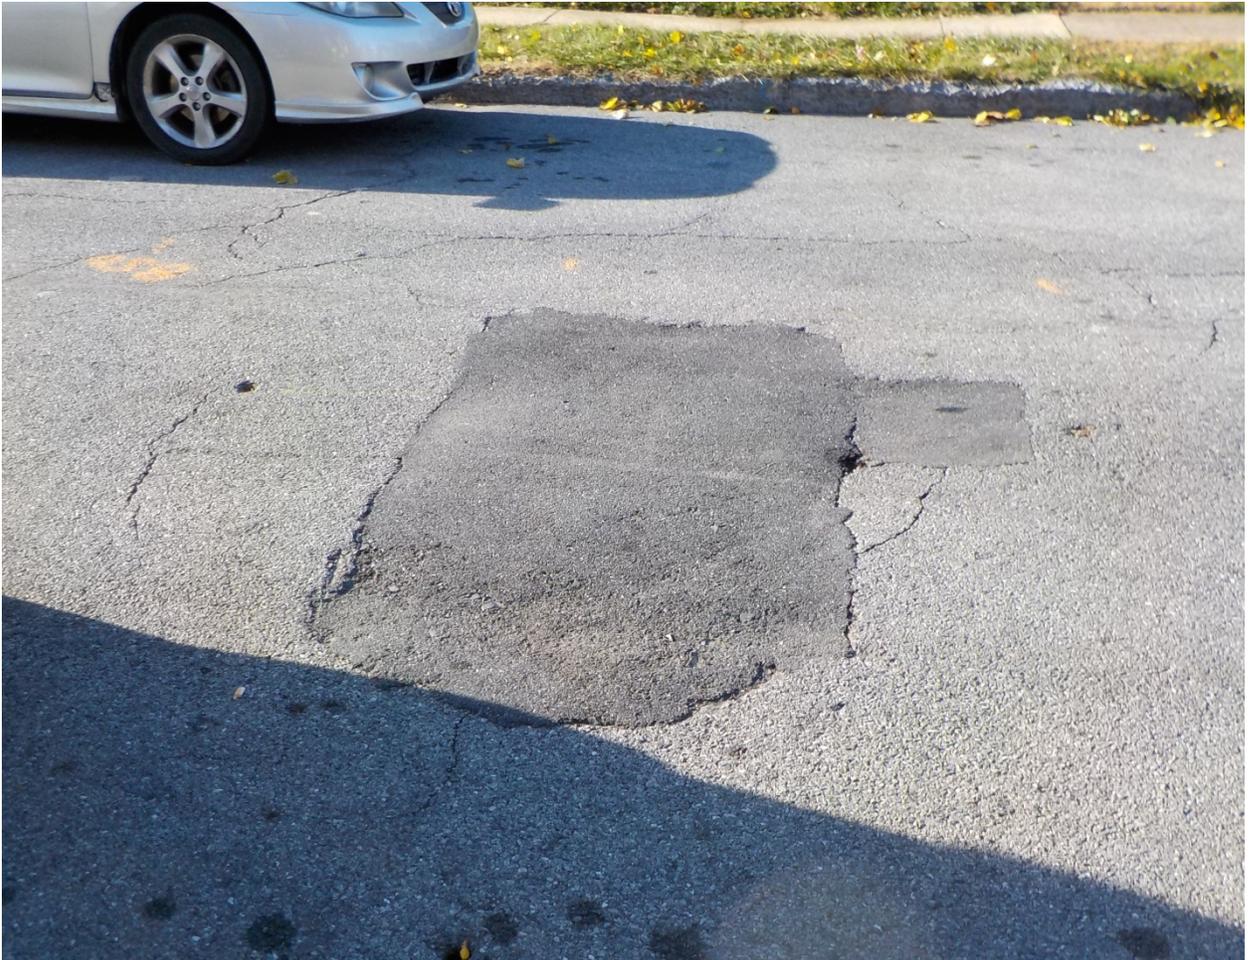
**Surface Feature 23**  
**Approximate Station 1000, S. 12<sup>th</sup> Street**

Asphalt Patch in 12<sup>th</sup> Street Across from Yard Sinkhole

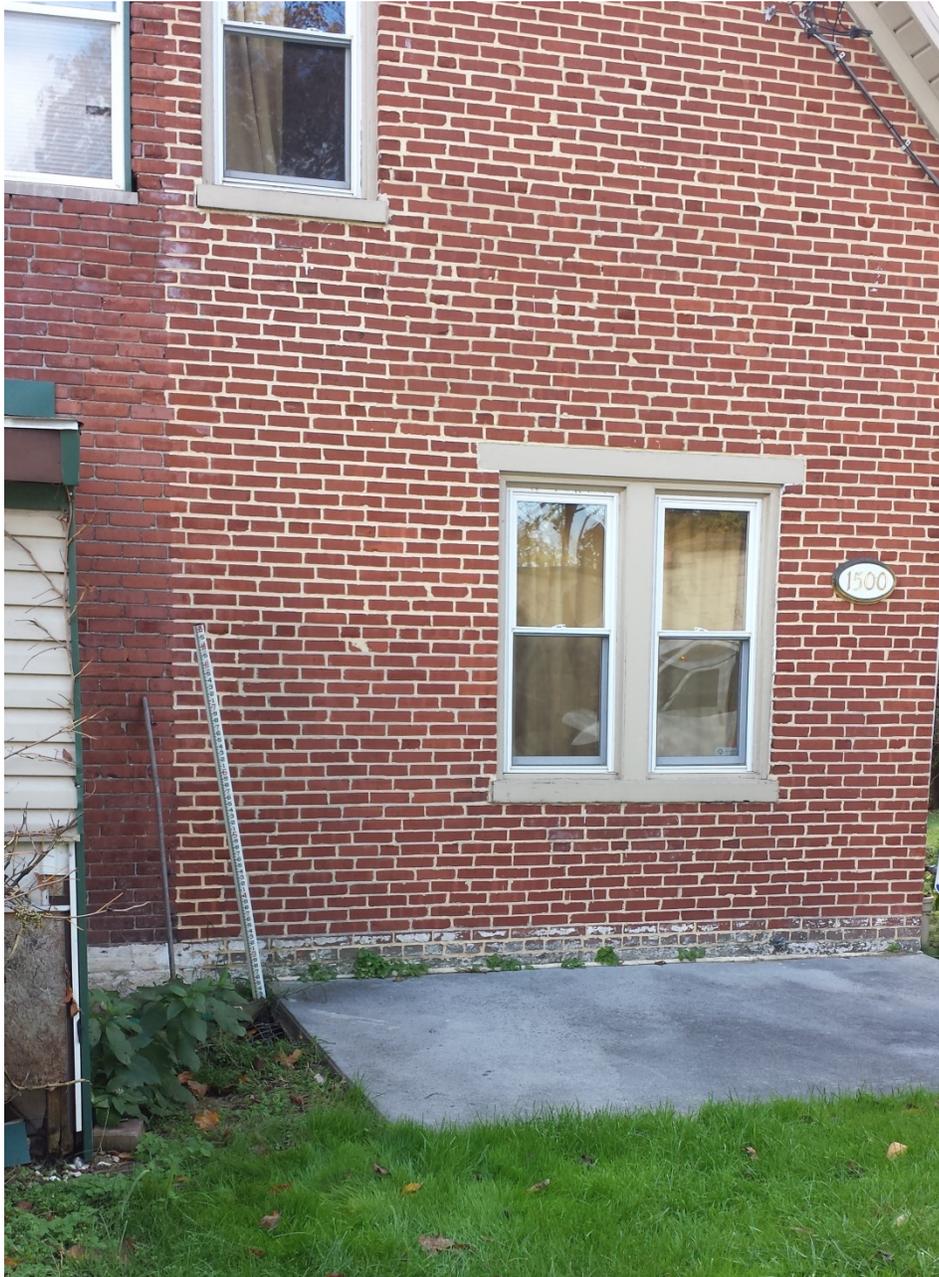
**Surface Feature 24**  
**Approximate Station 1125 S. 12<sup>th</sup> Street**

Depression under Concrete Pad  
Within Area Where Concrete was Replaced by Resident

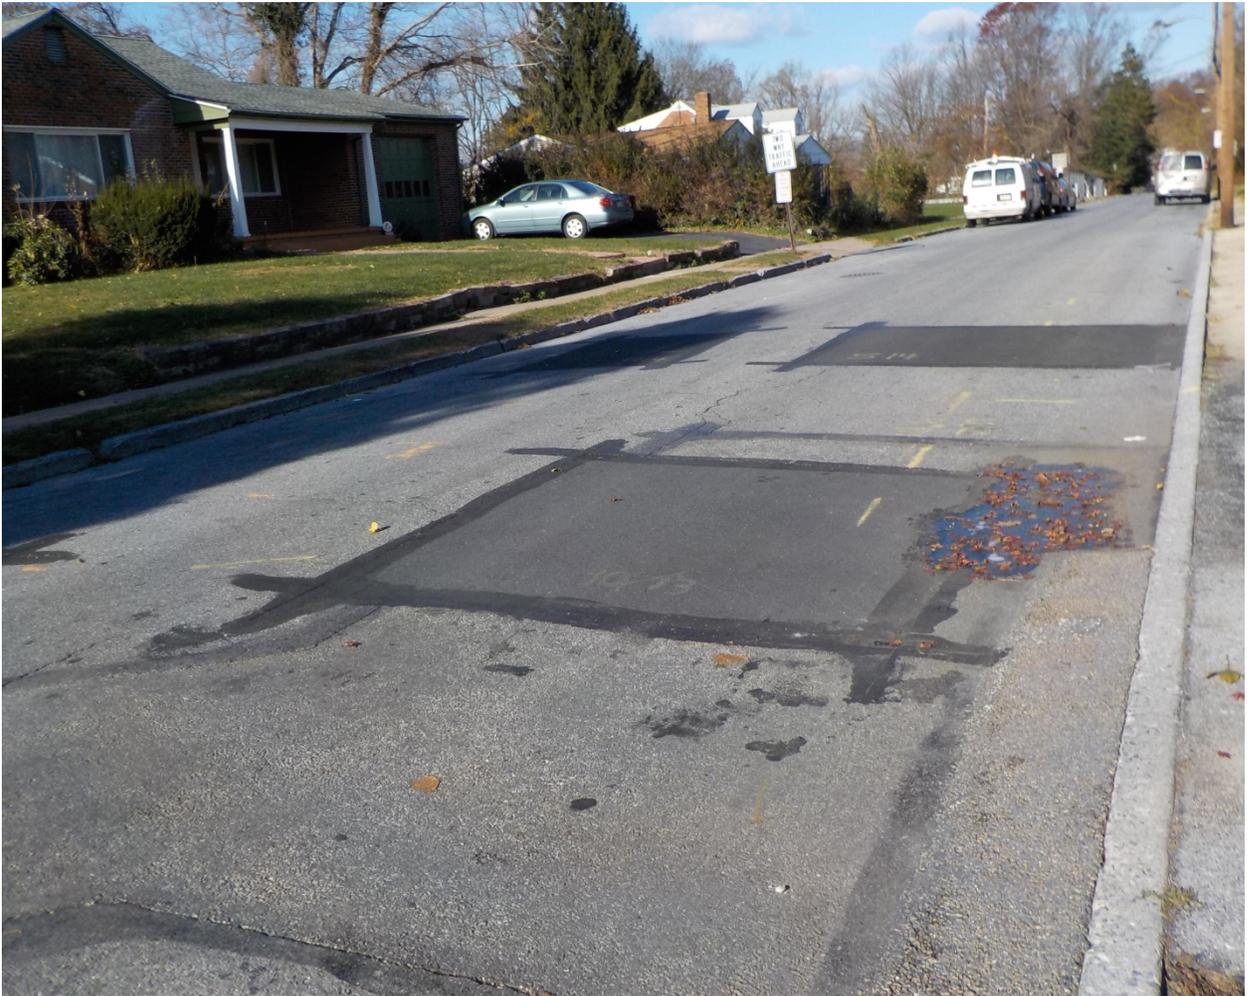
**Surface Feature 24**  
**Approximate Station 1125 S. 12<sup>th</sup> Street**

Asphalt Patches in S. 12<sup>th</sup> Street across from Observed Depression

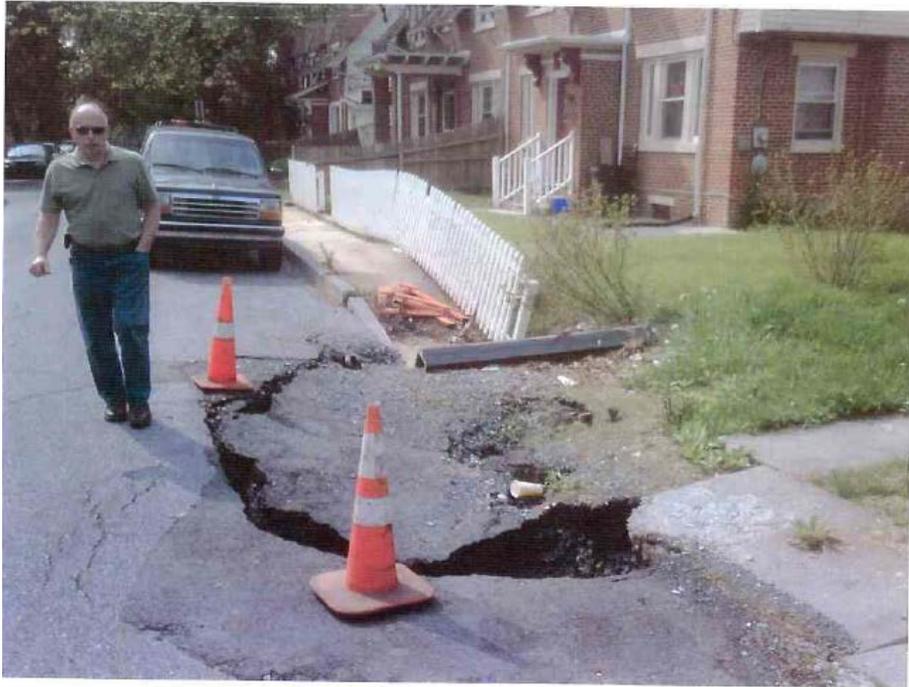
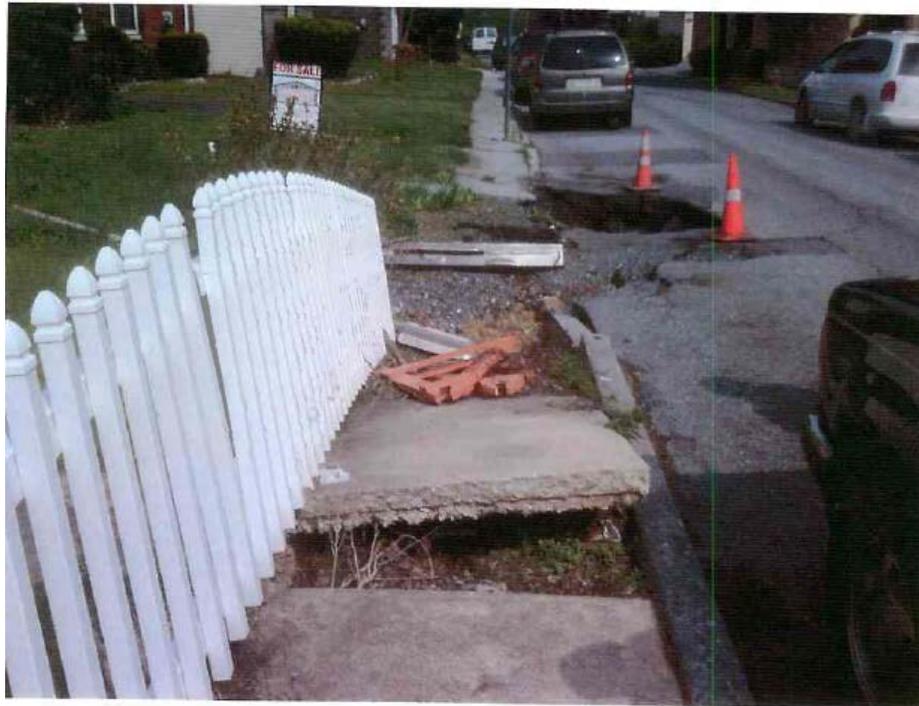
**Surface Feature 25**  
**Between Approximate Stations 1200 to 1225 S. 12<sup>th</sup> Street**

Sinkhole Repaired by City (City Photos)

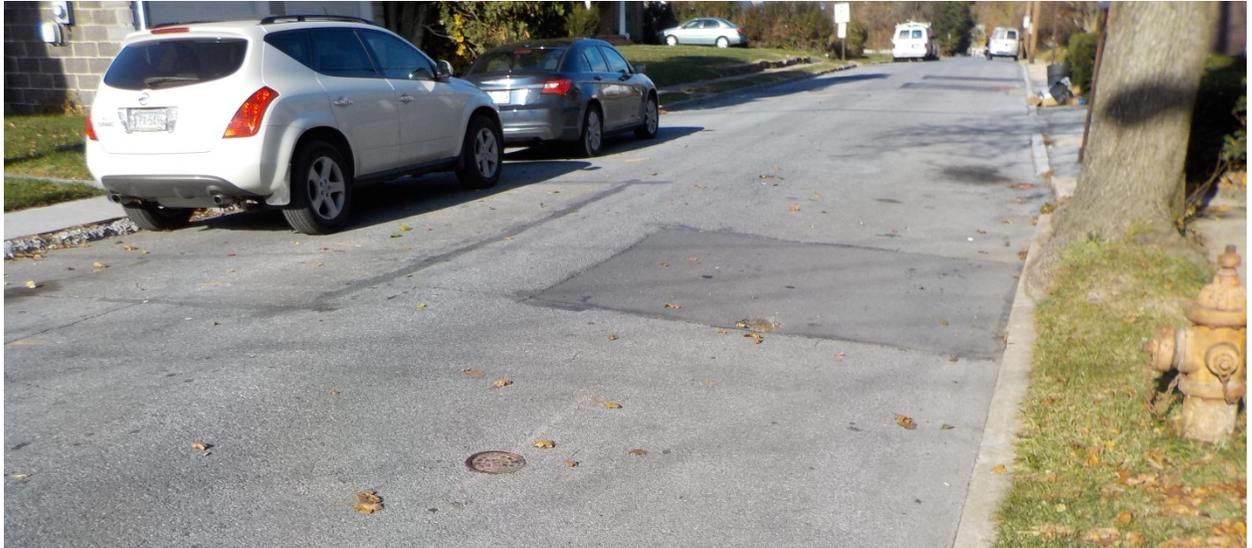
**Surface Feature 25**  
**Between Approximate Stations 1200 to 1225 S. 12<sup>th</sup> Street**

Pavement Patches and New Sidewalk Observed 11/18/2014

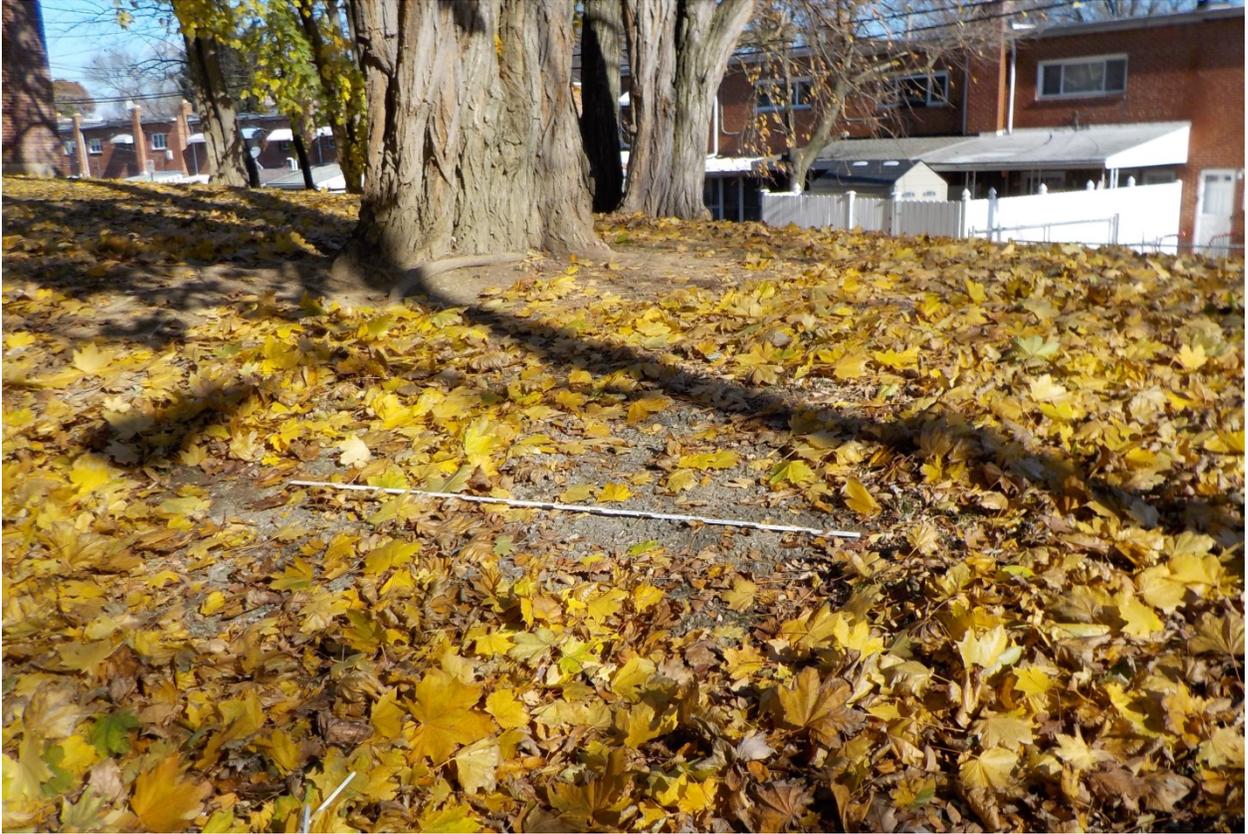
**Surface Feature 26**  
**Approximate Station 1450 S. 12<sup>th</sup> Street**

Evidence of Concrete Fill in Area Between S. 12<sup>th</sup> Street and Pigeon Street  
Local Resident Indicated that it was a Sinkhole Repair

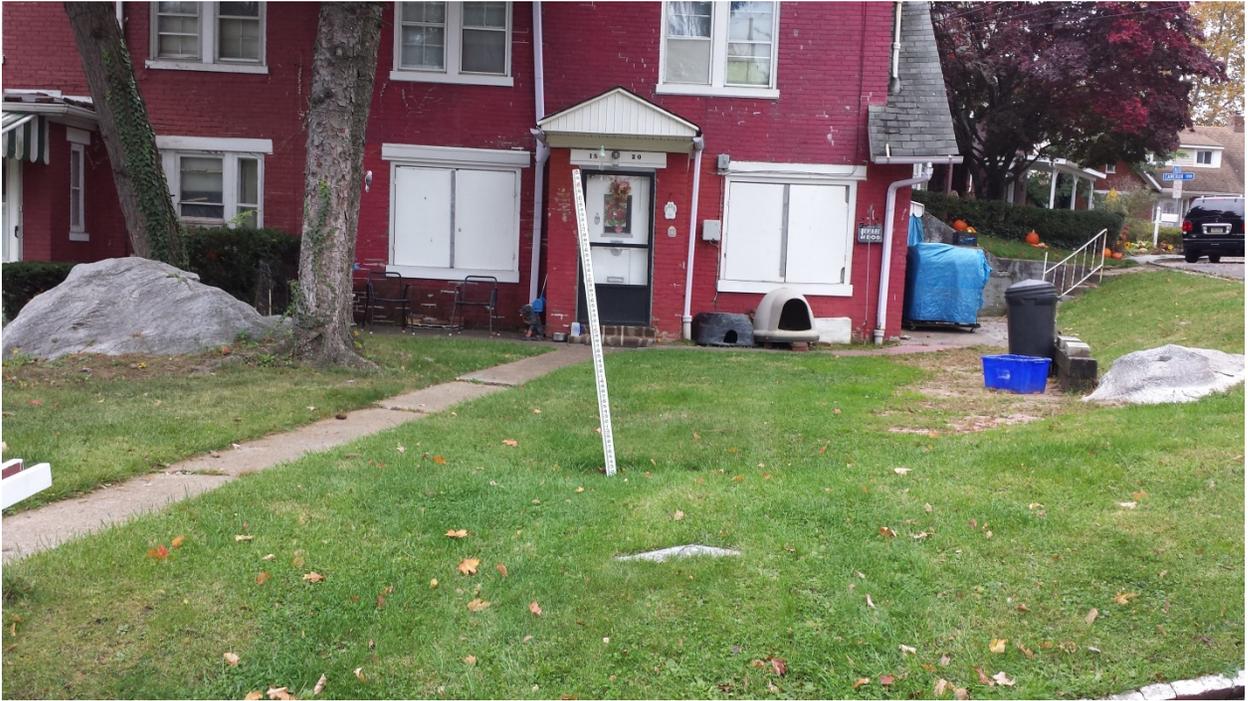
**Surface Feature 27**  
**Approximate Station 1650 S. 12<sup>th</sup> Street**

**Sinkhole in Front Yard**  
**Exposed Rock also Observed – Possible Outcrops**
