# **SOUTH HARRISBURG SINKHOLE EVALUATION WORK ORDER # 2**

## **HARRISBURG, PA**

**November 2014**

**Project Number: 59166**

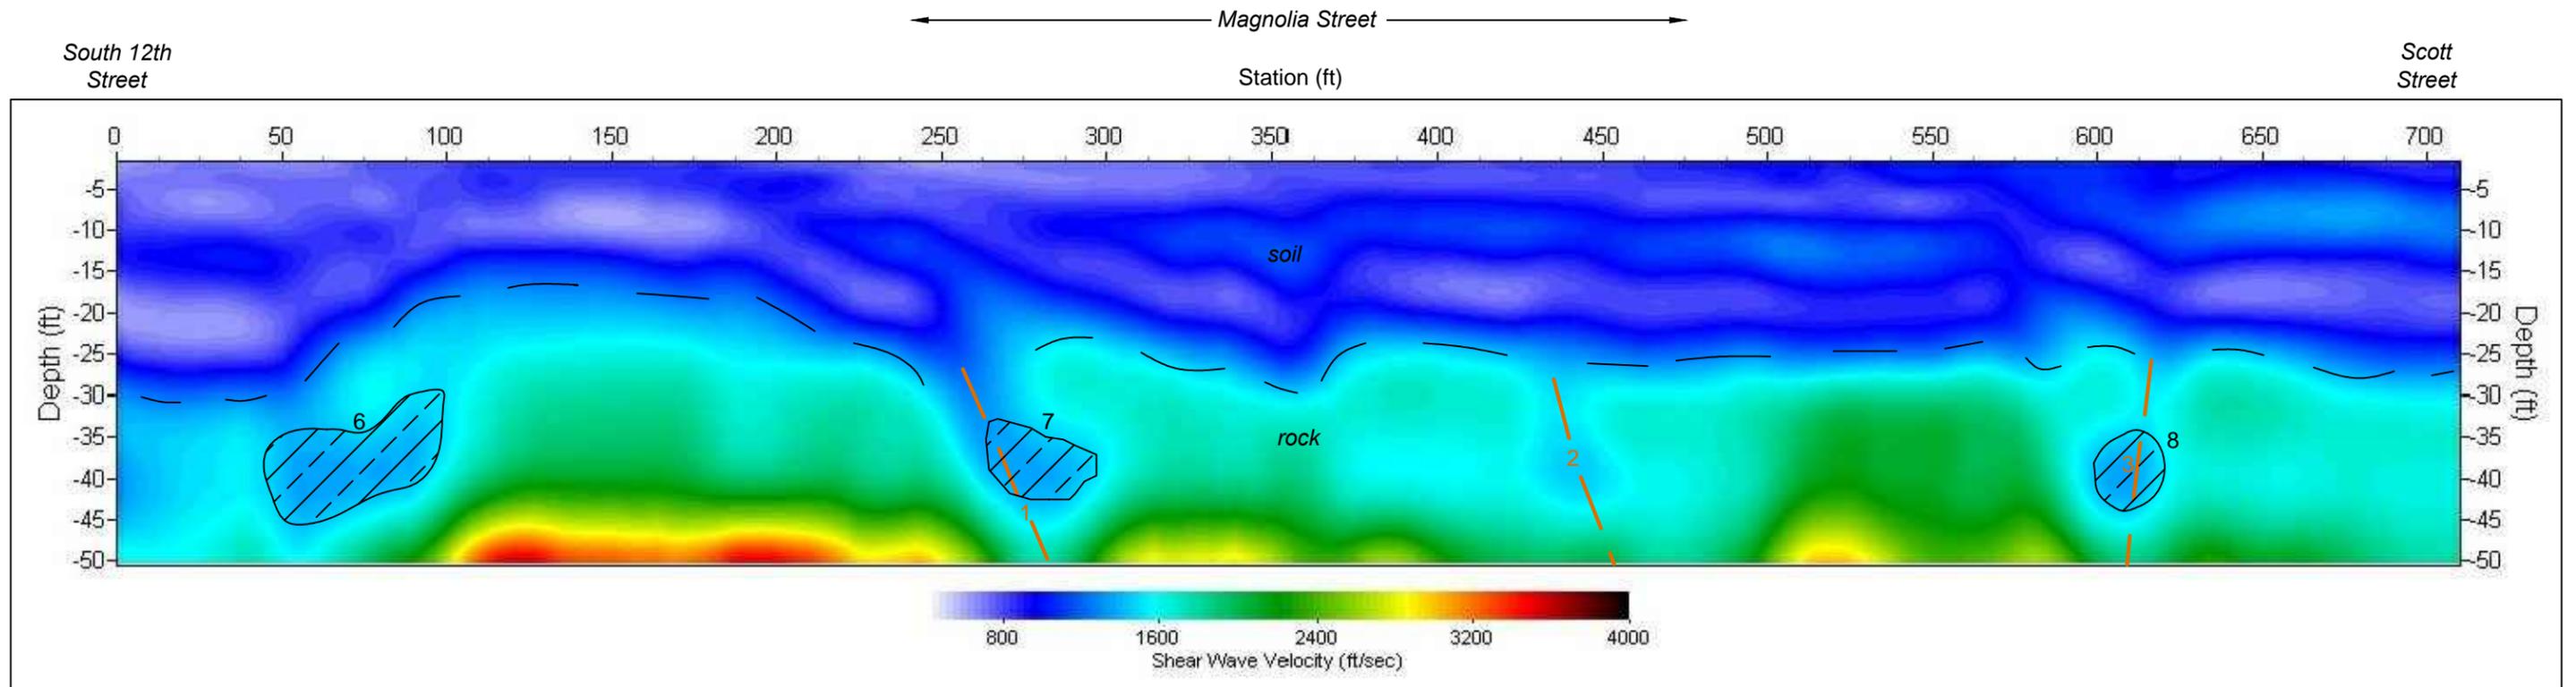
Magnolia Street  $V_s$  Profile  
 South Harrisburg Sinkhole Evaluation  
 Harrisburg, Pennsylvania

Twenty (20) fracture-like anomalies were observed. They are designated #1 through #20 in the profiles and are plotted in Figure 13. Some fracture-like anomalies such as #1 in Figure 4 and #10 in Figure 8 appear to extend to the top of the rock surface and are associated with a localized depression in the TOR. Soil piping (raveling) can be expected where fractures extend to the rock surface because fractures are planes of weakness that can allow soils to migrate into openings (voids) at depth.

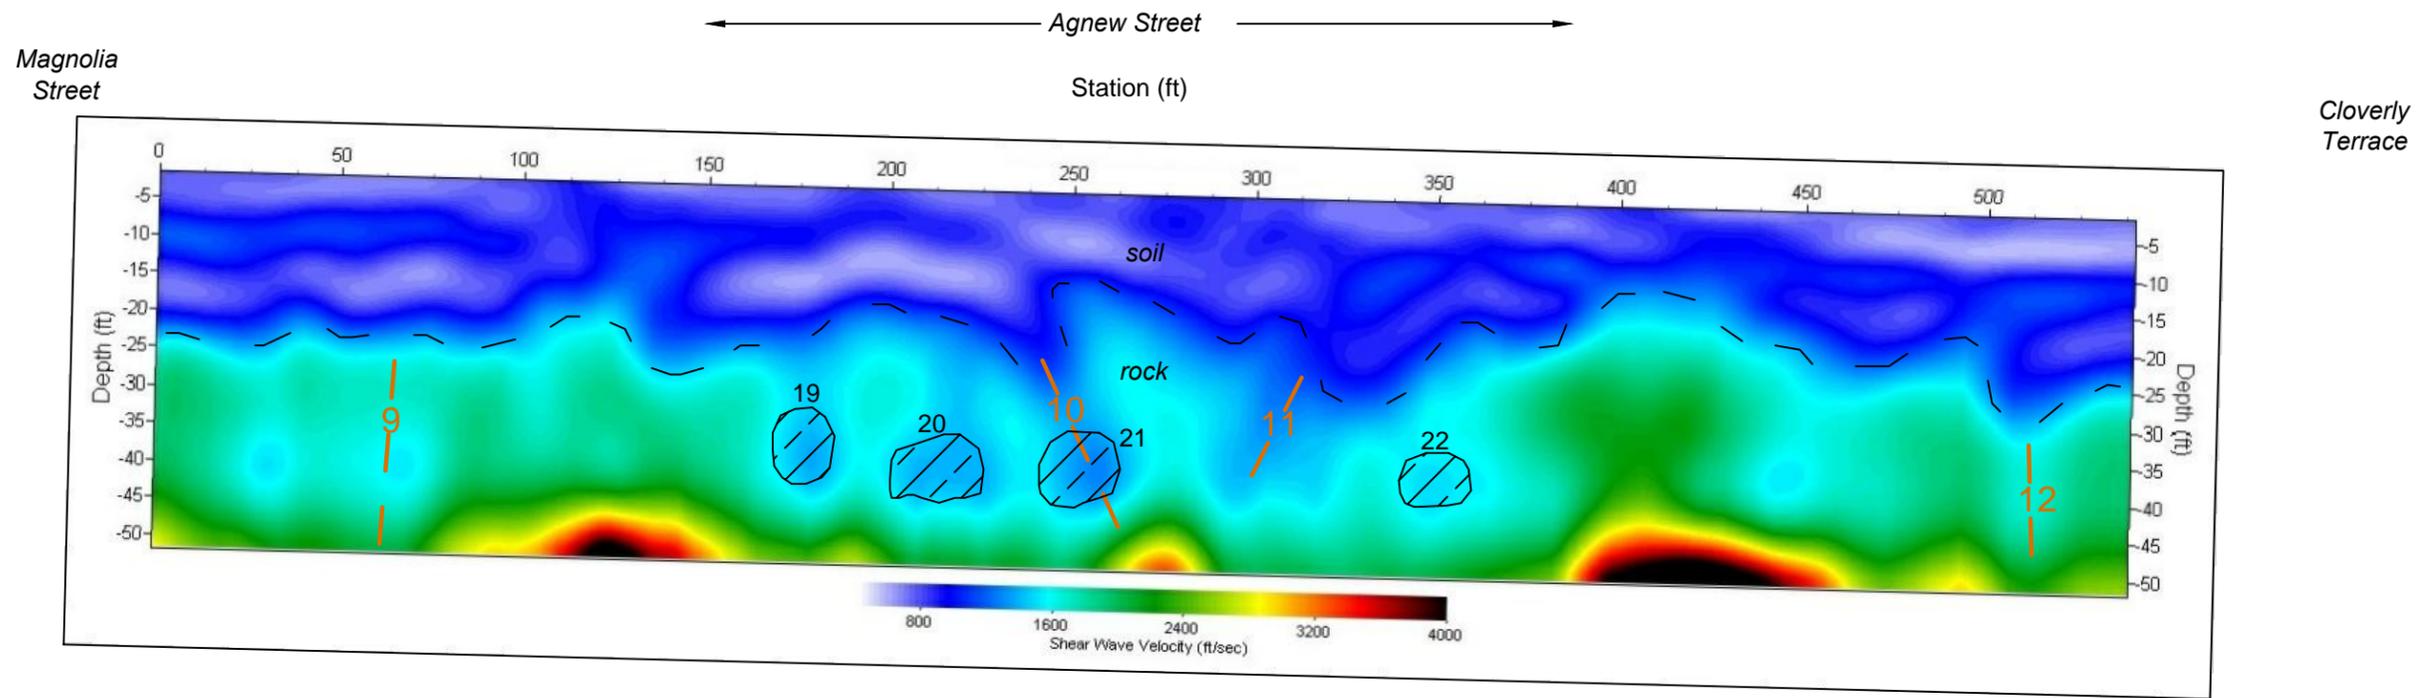
**Agnew Street  $V_s$  Profile**  
**South Harrisburg Sinkhole Evaluation**  
**Harrisburg, Pennsylvania**

In general, top of rock (TOR) is equivalent to approximately 1,200 fps, based upon the verification boring conducted in Work Order #1. In the Work Order #2 study area, TOR varies from approximately 15 feet to 40 feet below ground surface (BGS). The TOR surface also varies from relatively flat (e.g., S. 13<sup>th</sup> Street, Hanover St. to Cloverly Terrace, Figures 9A and 9B) to highly irregular (e.g., Agnew Street, Figure 8). In the local limestone geology, an irregular rock surface is generally due to pinnacles.

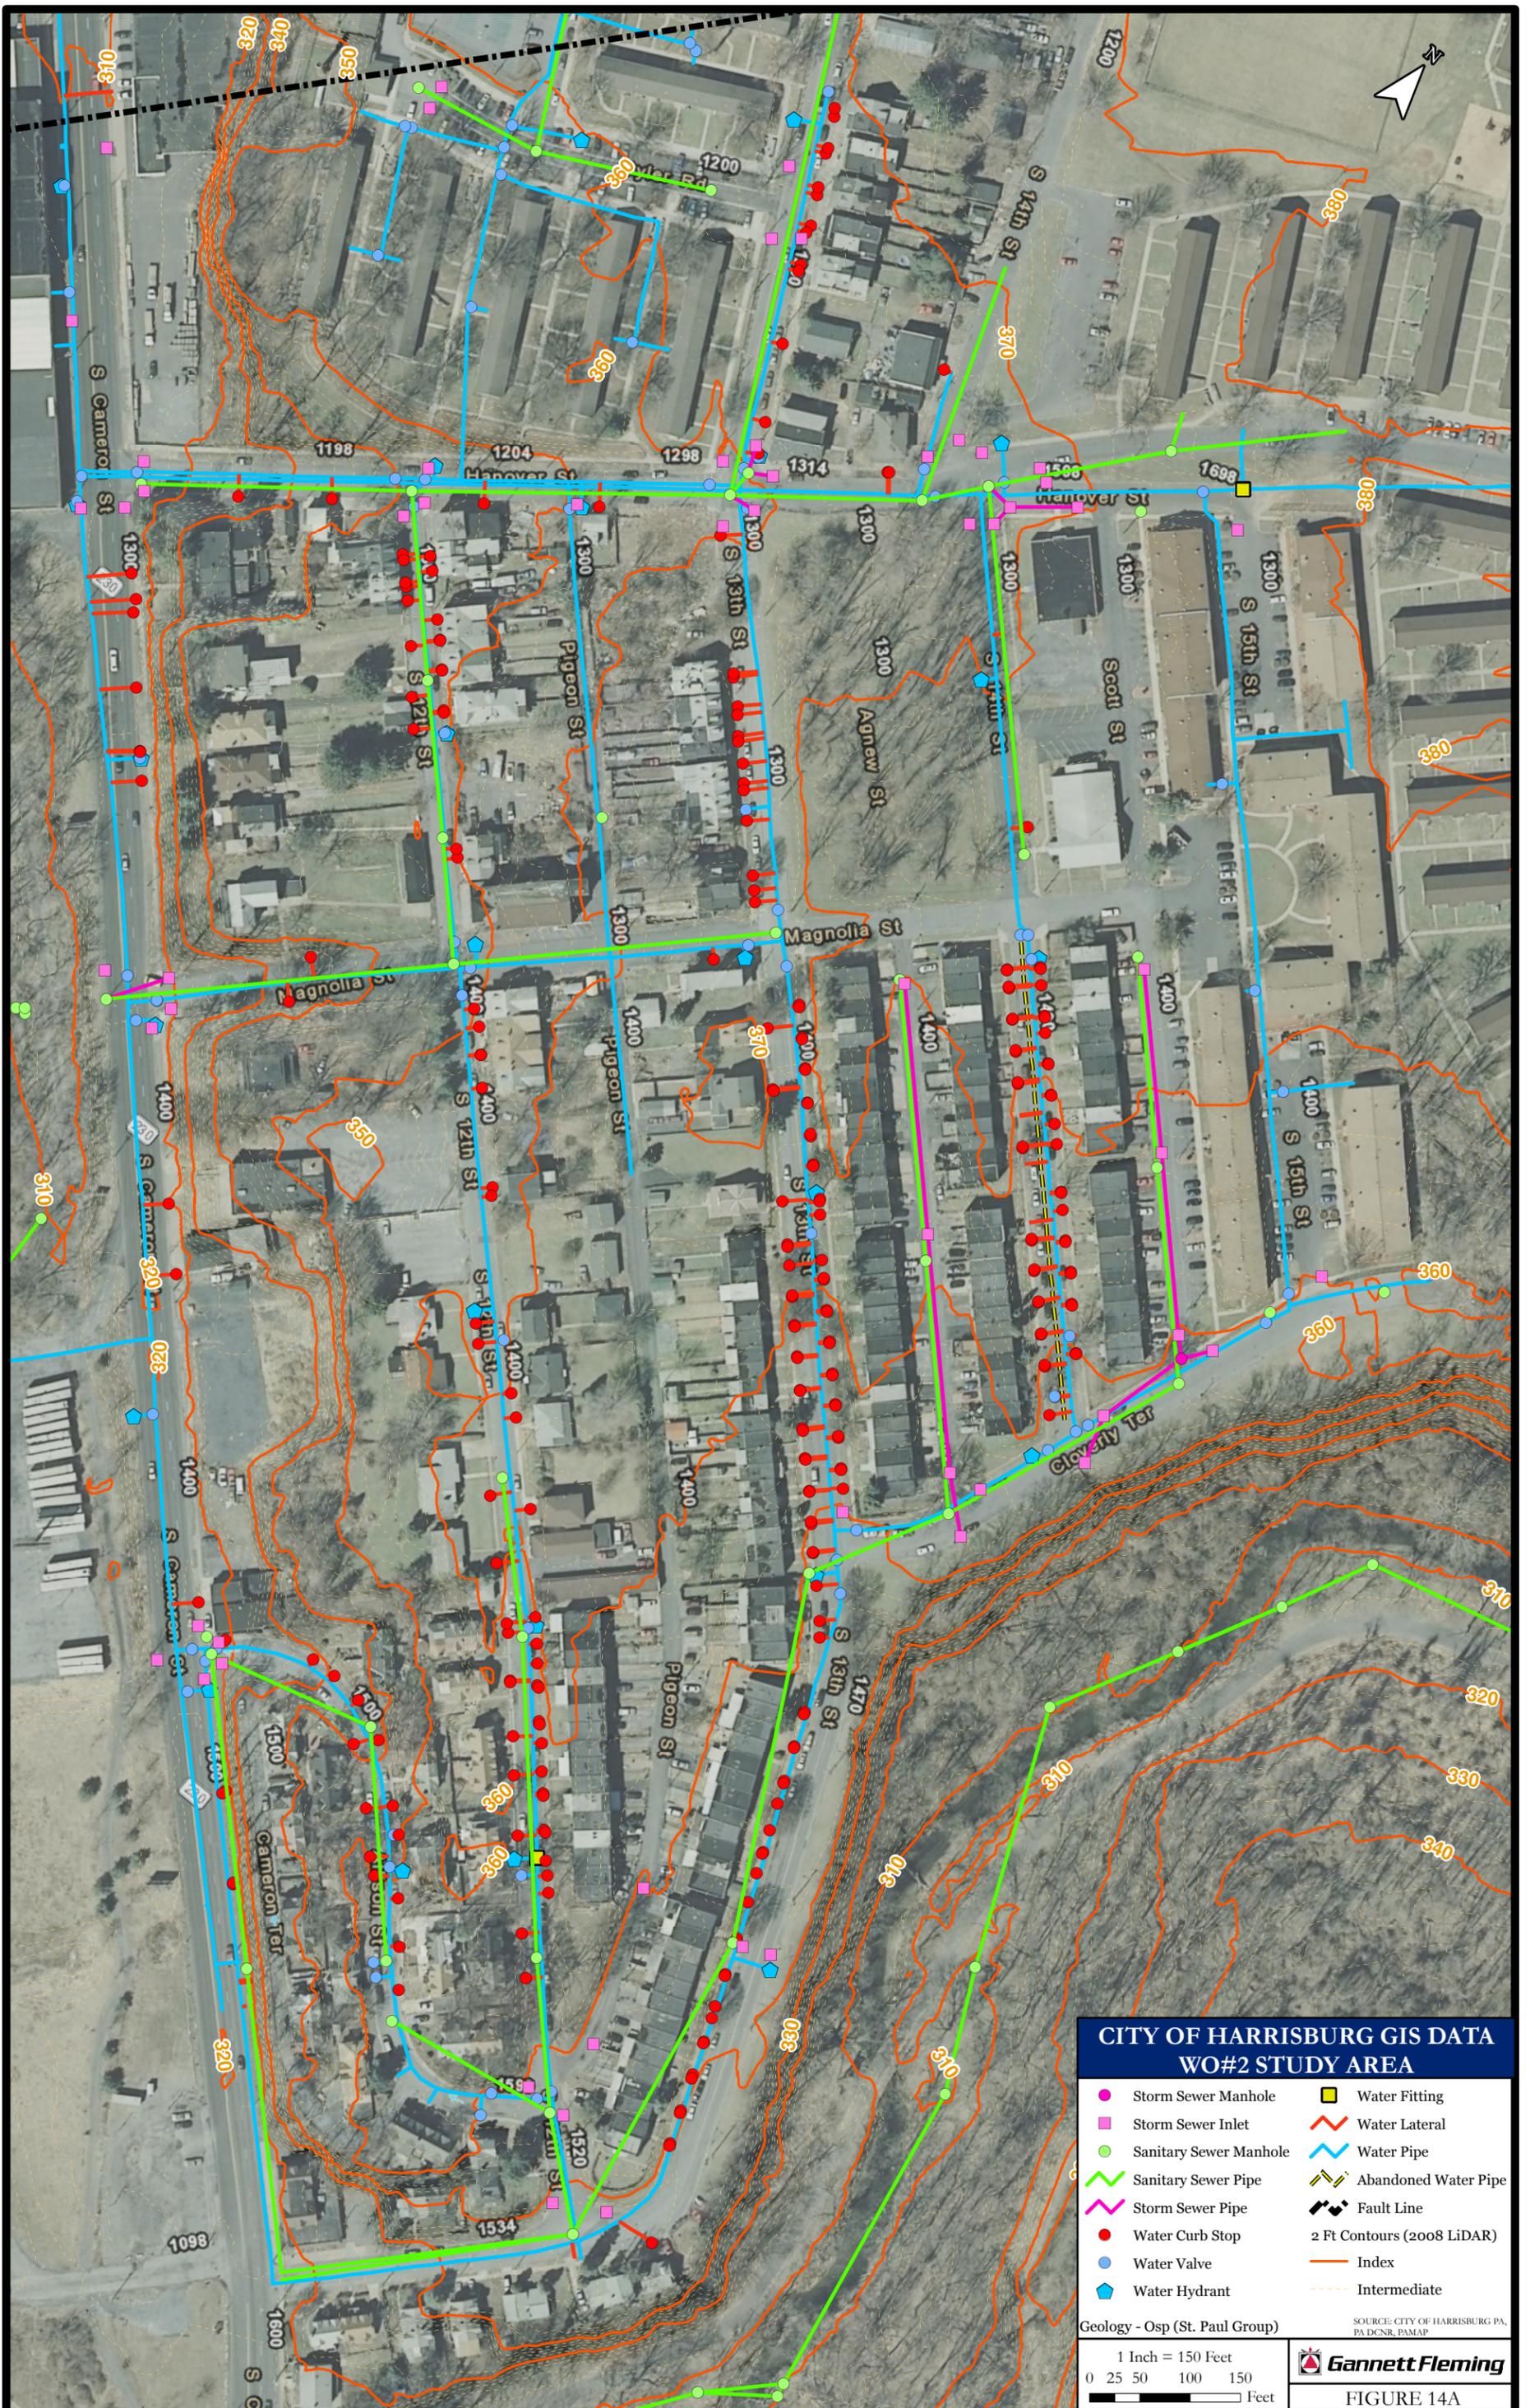
For: City of Harrisburg			Figure
Date: 11-20-14	Project No.: 059166.WO2QTM	File: O:\City of Harrisburg\Fig 13.dwg	<b>14B</b>

The location of water, sanitary and stormwater pipes are shown on Figures 14A and 14B. Figure 14B is an overlay of the utility data on a line diagram of the geophysical findings. Many of the subsurface features identified by the MASW survey (potential voids or fracture-like anomalies) and all of the surface features are in the vicinity of one or more underground utility facilities. However, subsurface features were also identified along roadways with no utilities, such as Scott Street between Hanover Street and Magnolia Street, and most of Pigeon Street between Magnolia Street and S. 12<sup>th</sup> Street. Additionally, the site reconnaissance was performed along streets and sidewalks where the majority of utilities are located.
